**National
Transportation
Safety Board**

Perspectives and Recommendations for the Natural Gas Industry

Natural Gas Pipeline Accident

Manhattan, New York

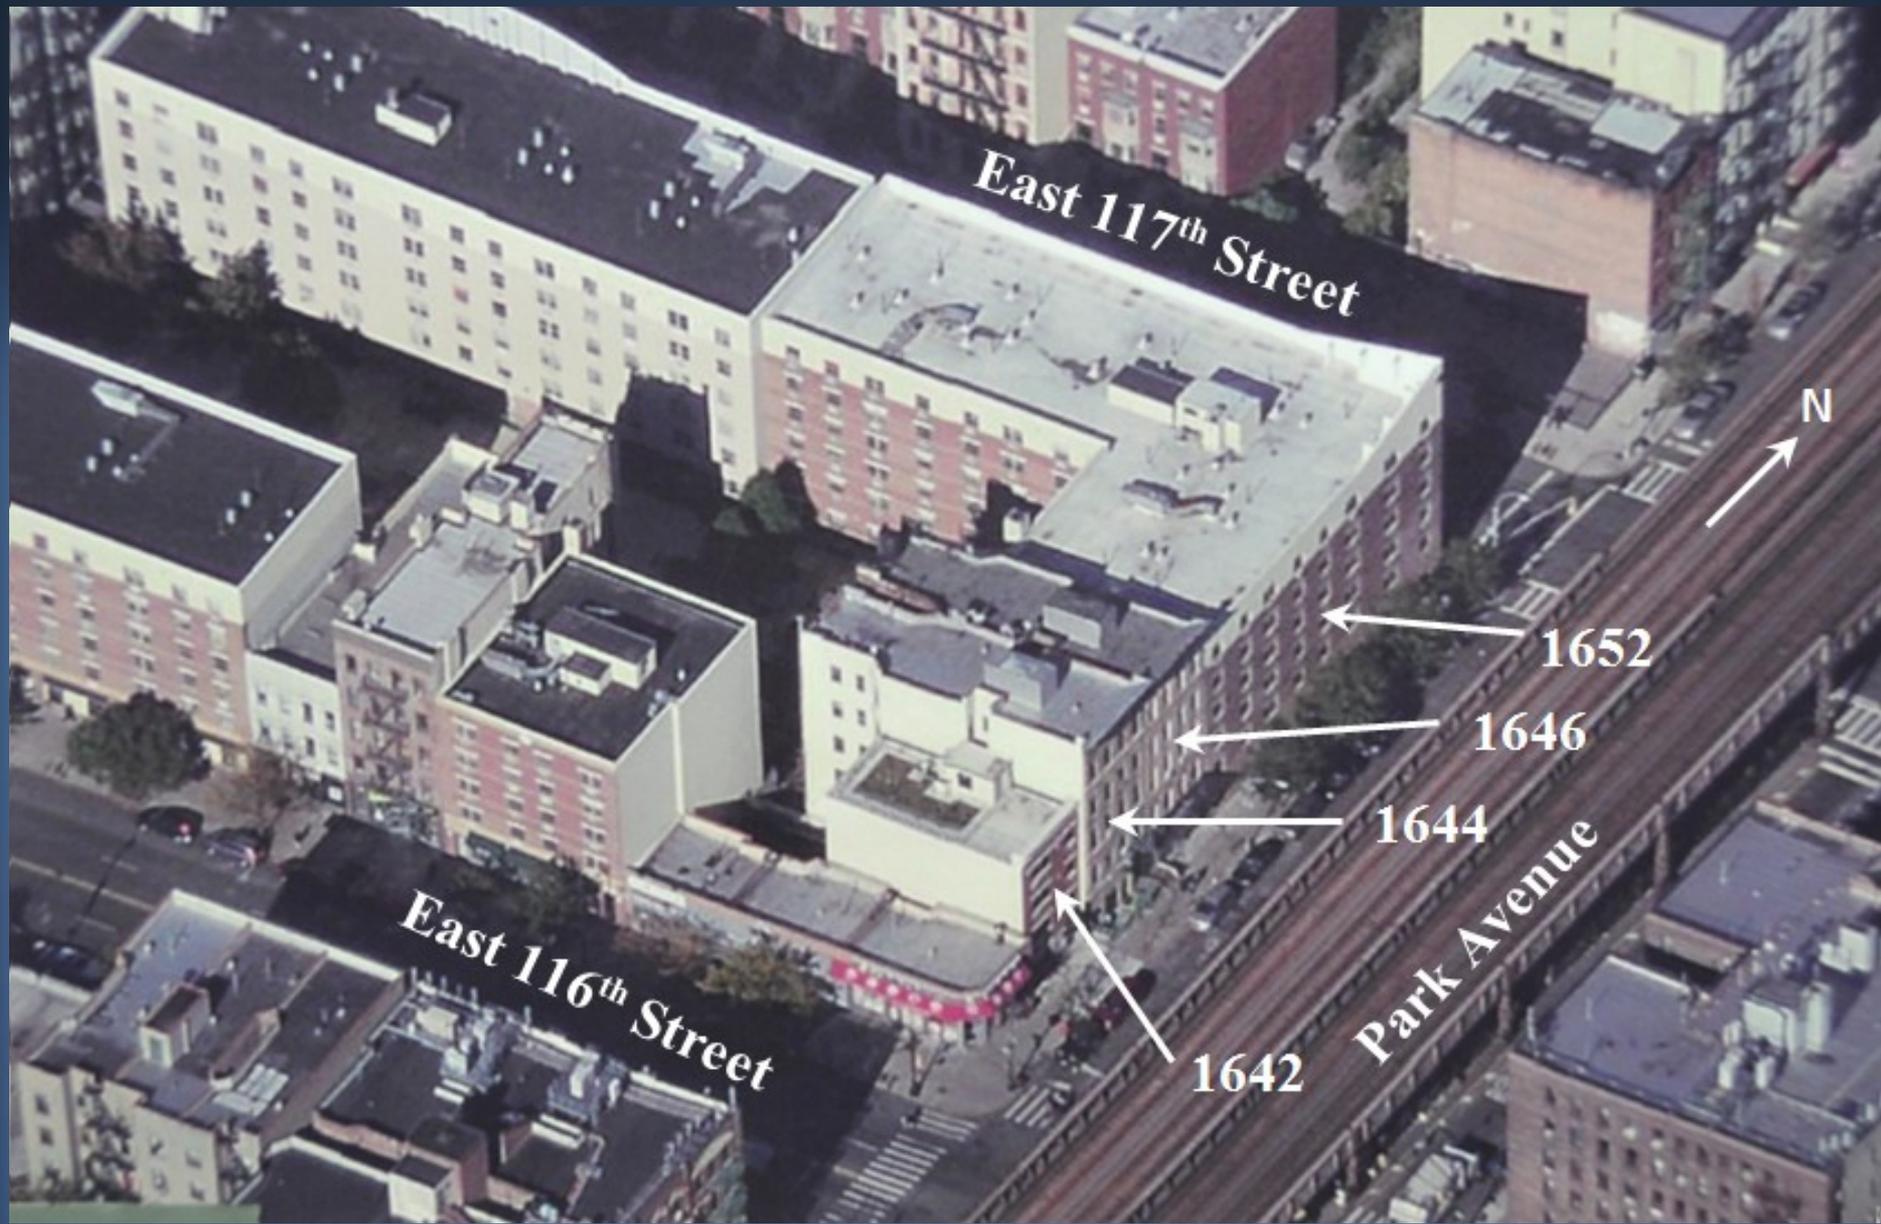
Manhattan, New York (Harlem)

- Consolidated Edison
- 8-inch cast iron/plastic distribution line (1890 / 2011)
- 8 in wc MAOP, 6 in wc operating
- 8 Fatalities
- 48 injuries

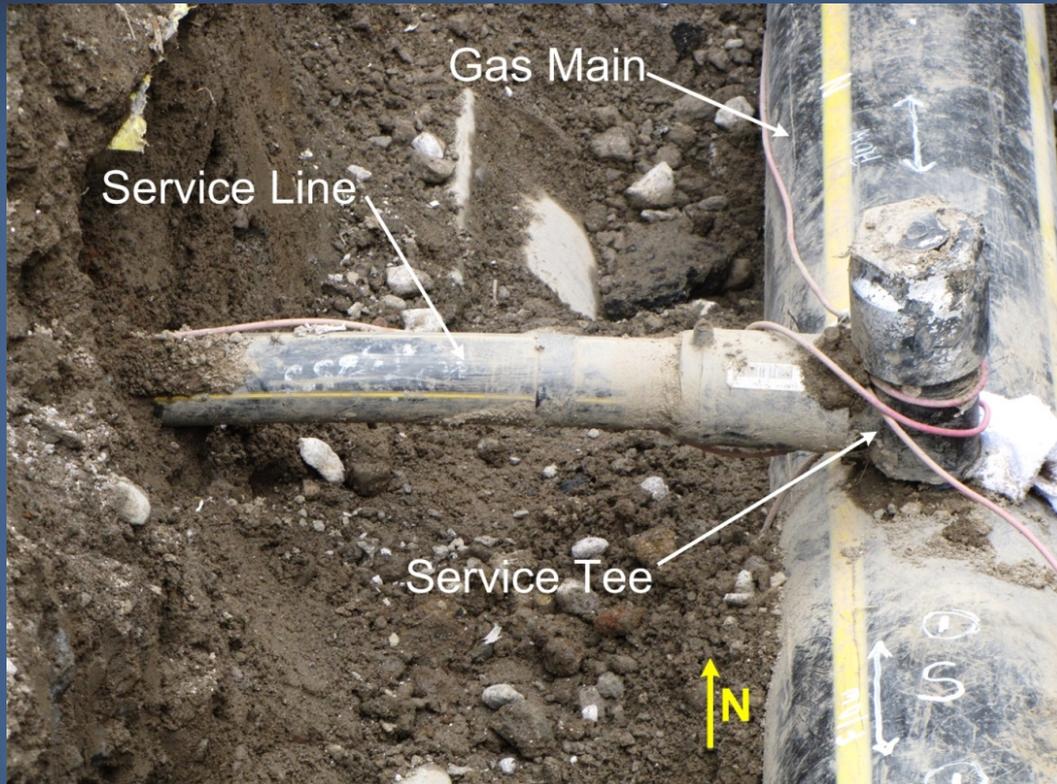
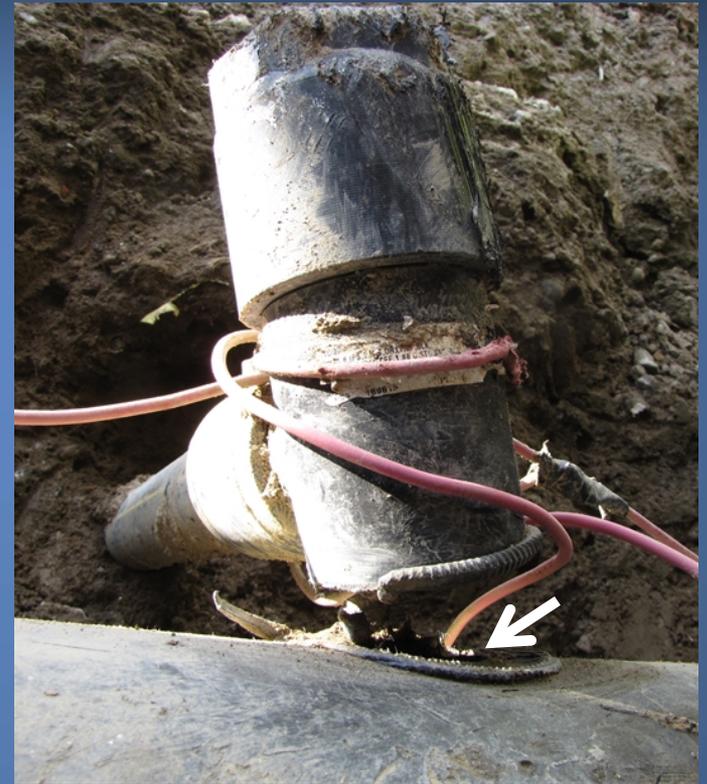
Fusion Joint – Incomplete Fusion

- Radial band pattern (60%)
- Is incomplete fusion
- Is a weld defect
- Weak bond strength
- Caused by contamination or inadequate surface preparation before fusion welding

- City of New York - Improve sewer main integrity process
- Consolidated Edison - Revise plastic pipe fusion procedure
 - Cleaning methods
 - Improve final visual inspection

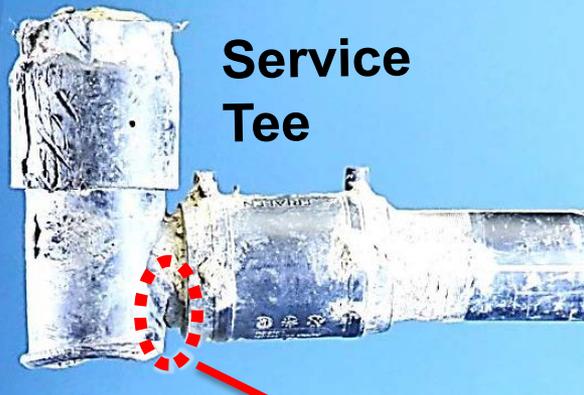
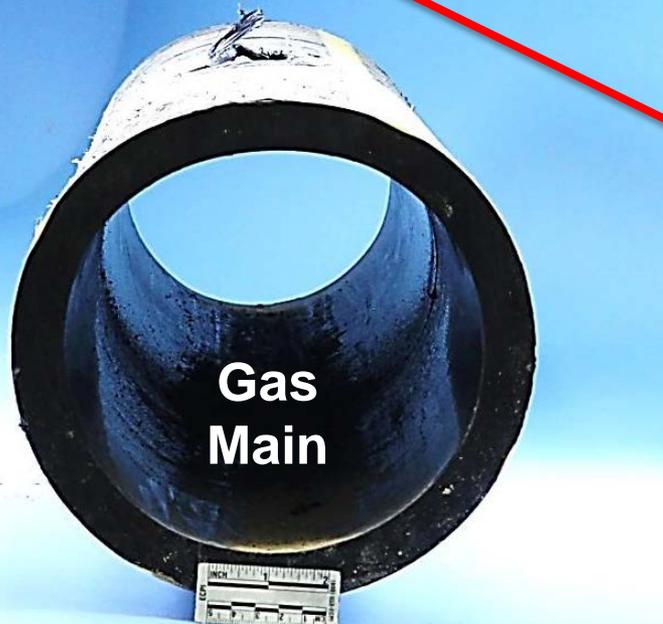
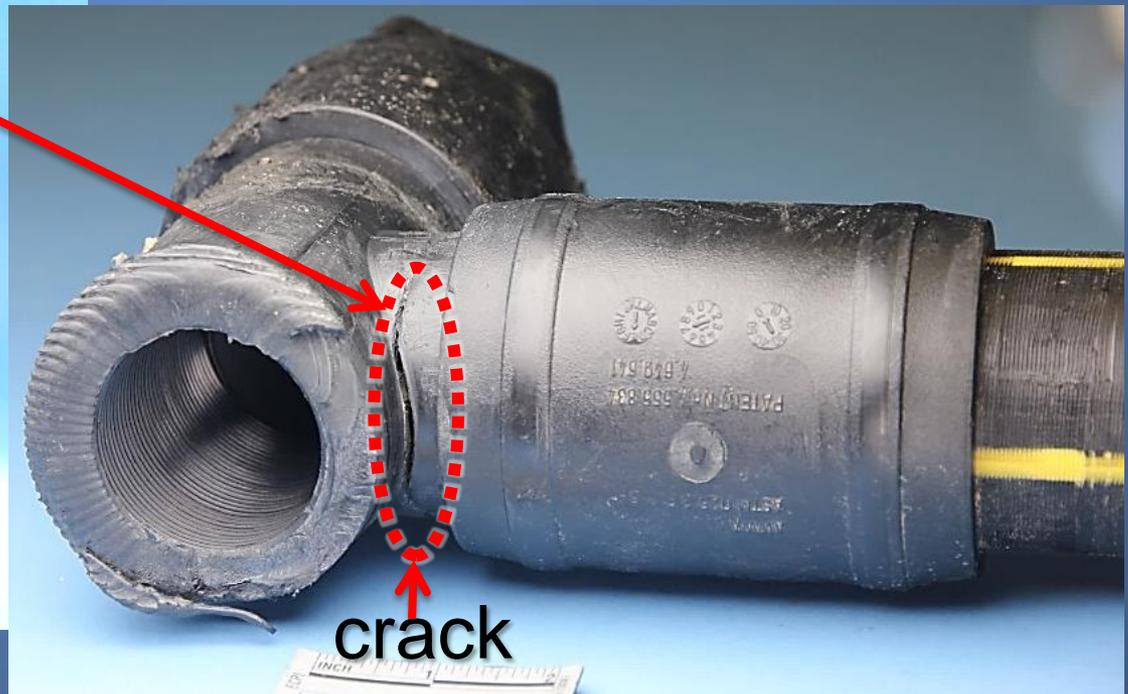
Service Tee – Crack at Outlet

- No evidence of pre-existing crack
- Rapid loading event from post-accident excavation

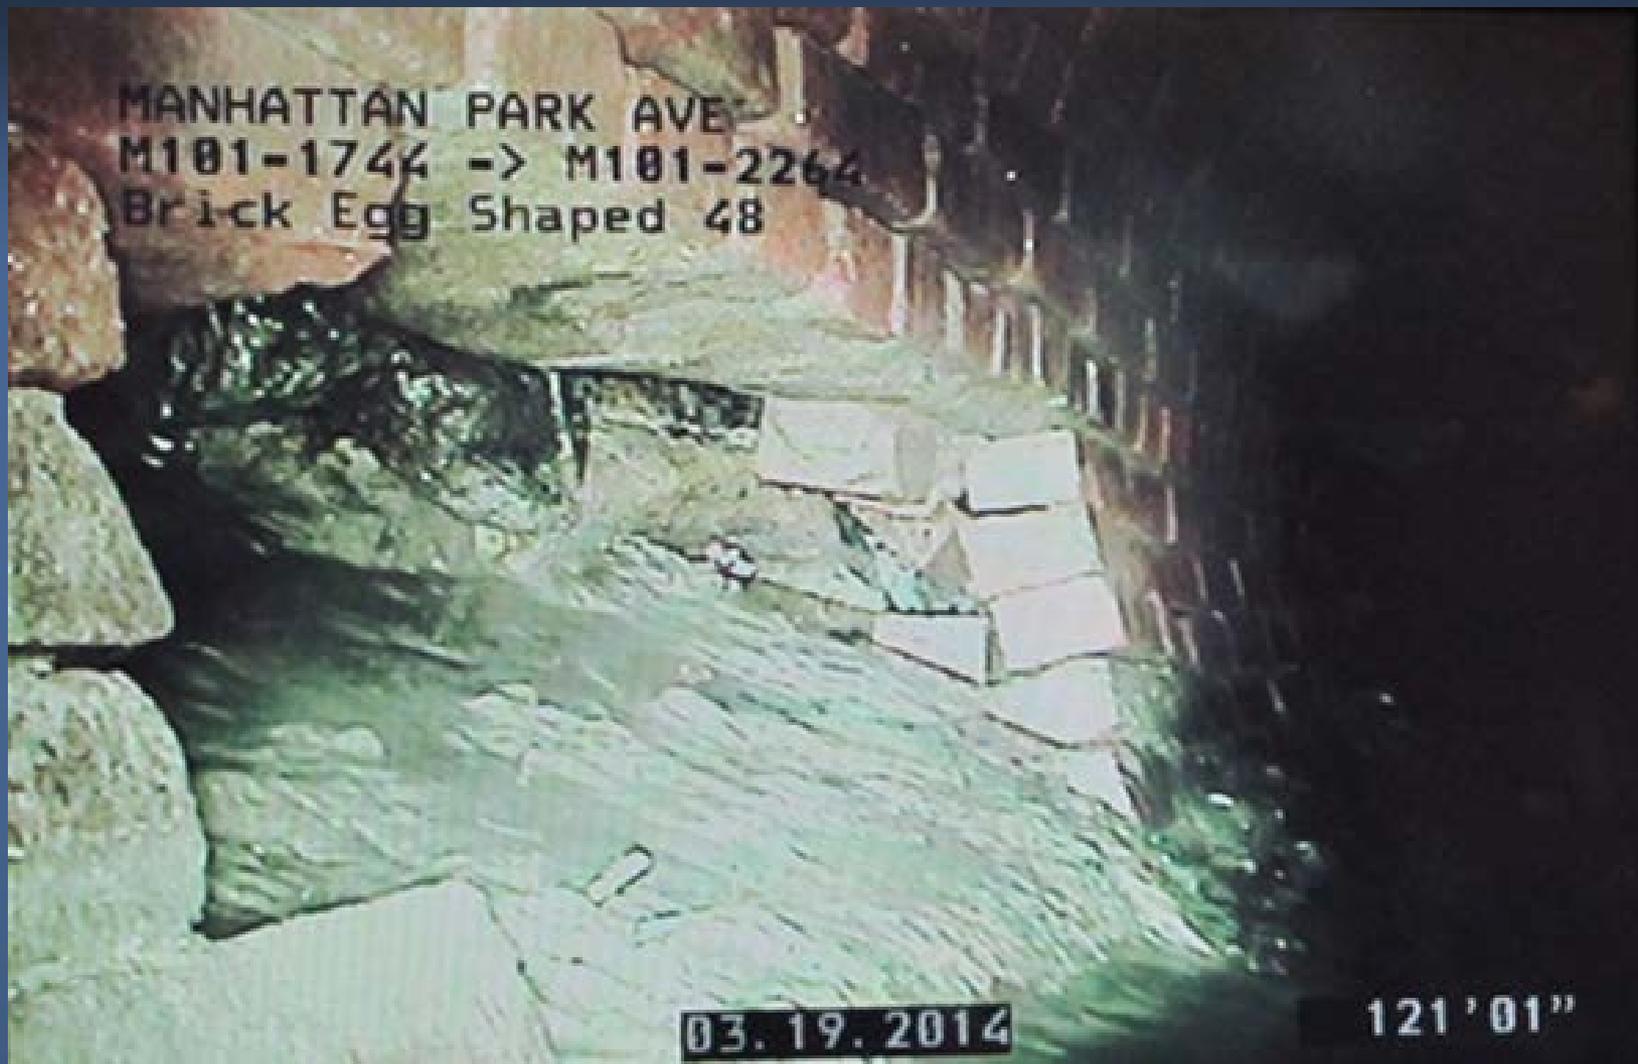
2014 Sewer Main Damage

- Large hole in the sewer dated back to 2006
- Service tee to gas main weld not properly cleaned – lack of fusion
- Supporting soil under the plastic gas main washed into the damaged sewer for many months
