Collaboration for Pipeline Safety

CGV Shallow Transmission Mains
10/21/2015

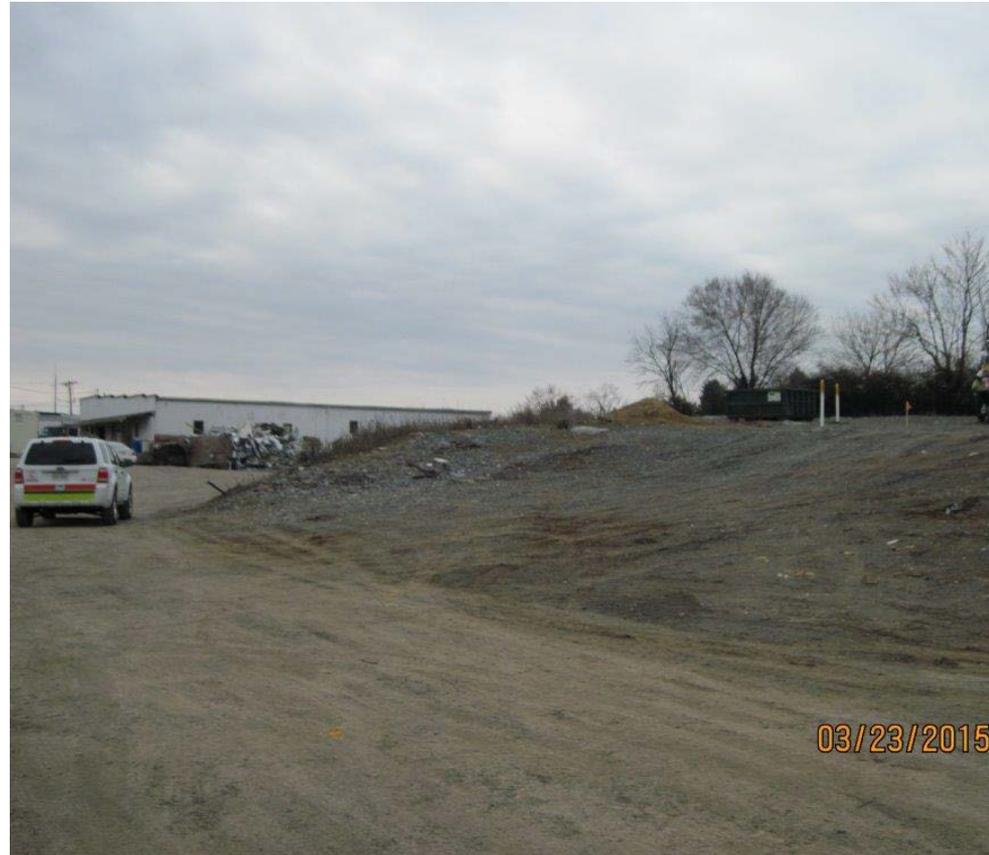
Immediate Concern “Scrap Yard”

- 3rd party grading
- 17” of cover
- Leak Survey
- Above ground electrical survey
- Direct Assessment
 - Visual
 - Weld Inspection
 - Mag Particle

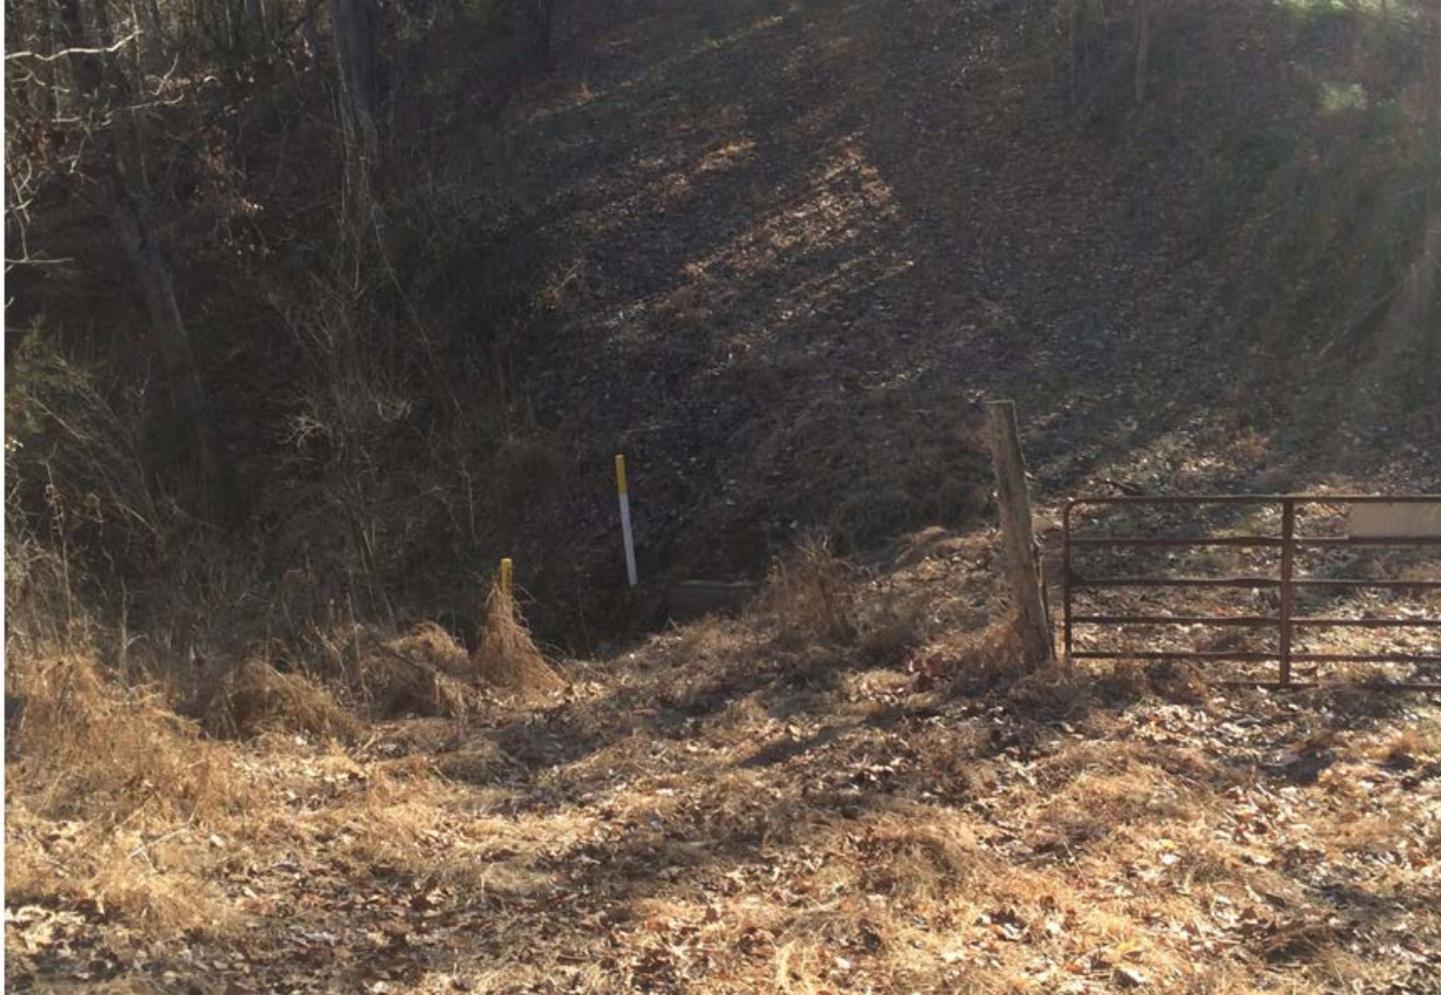
Erosion “Wash Out”

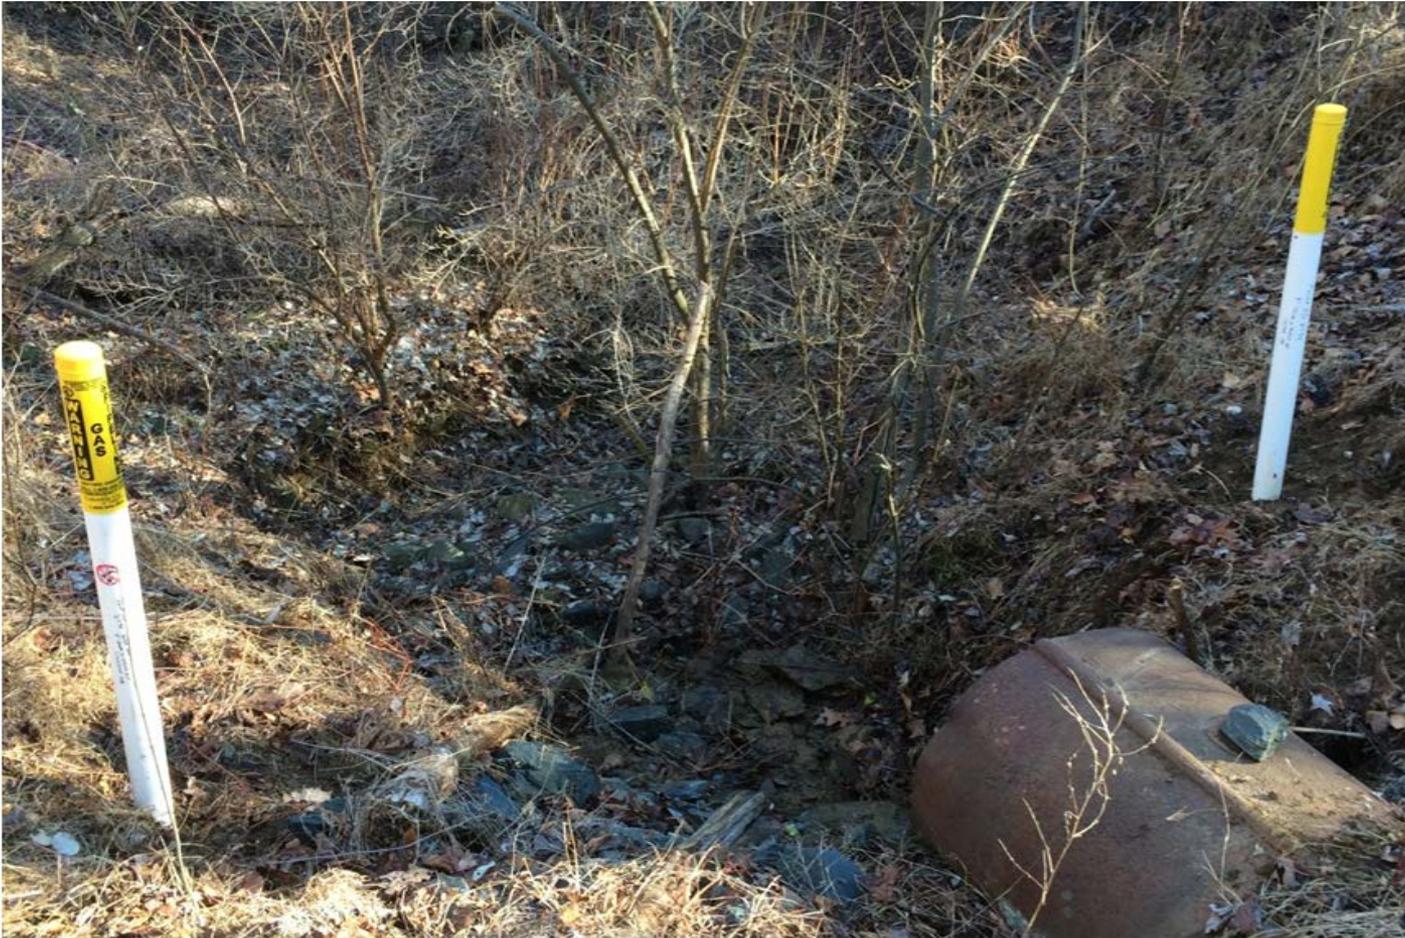
Wash Out (6" Cover)

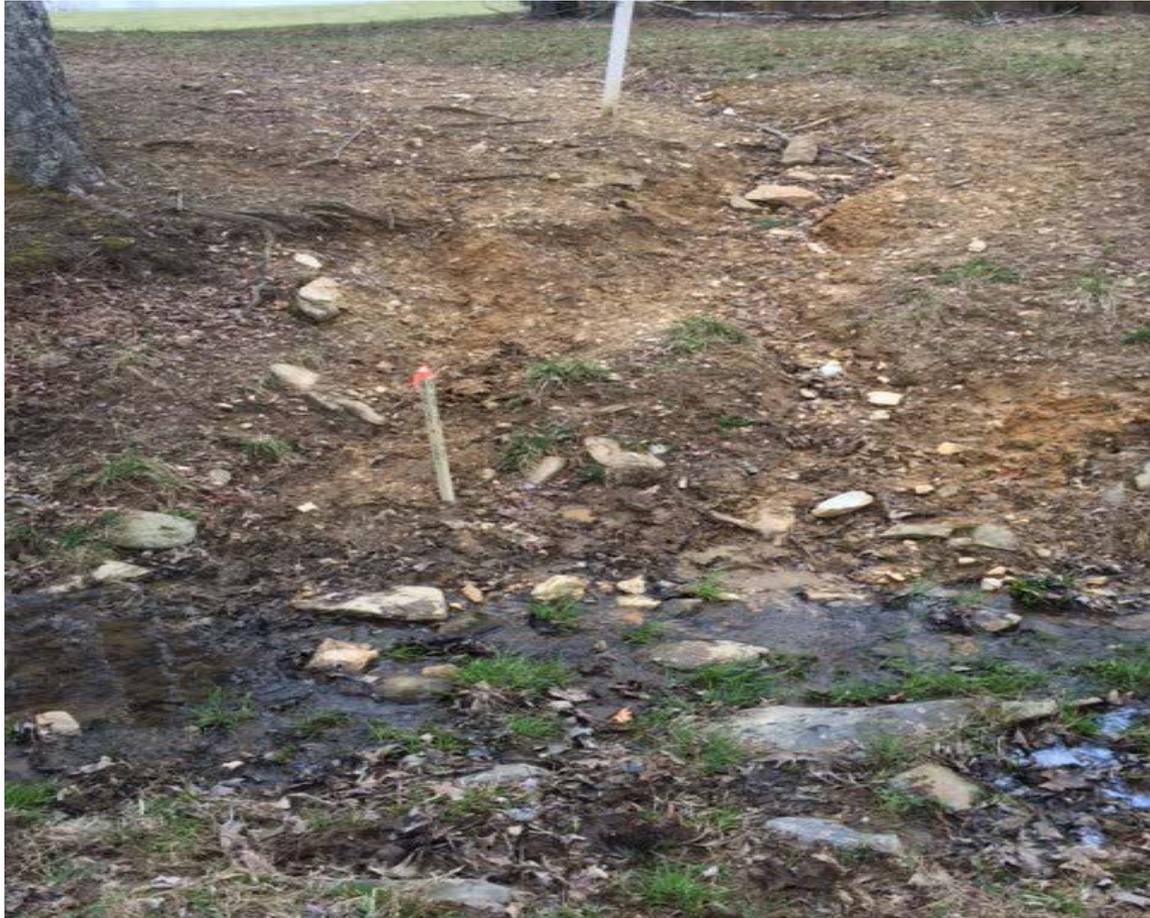
Erosion “Wash Out”

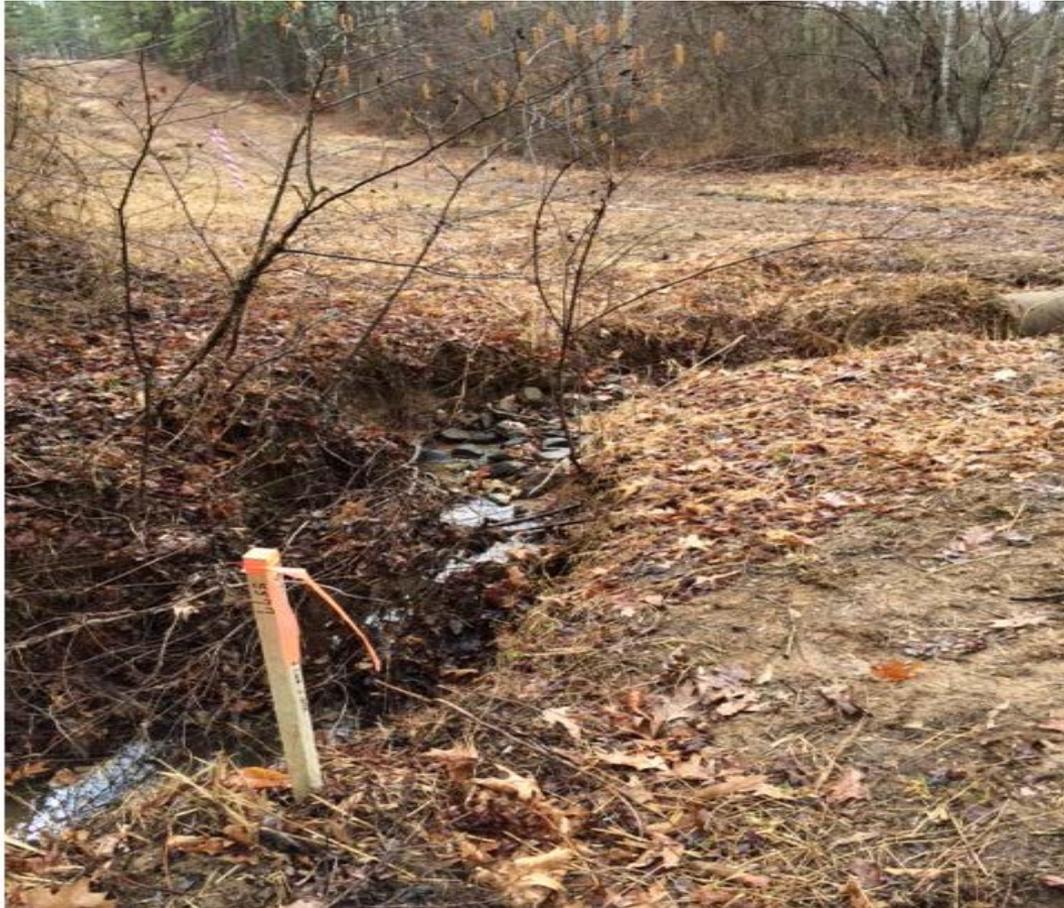
Erosion “Wash Out”

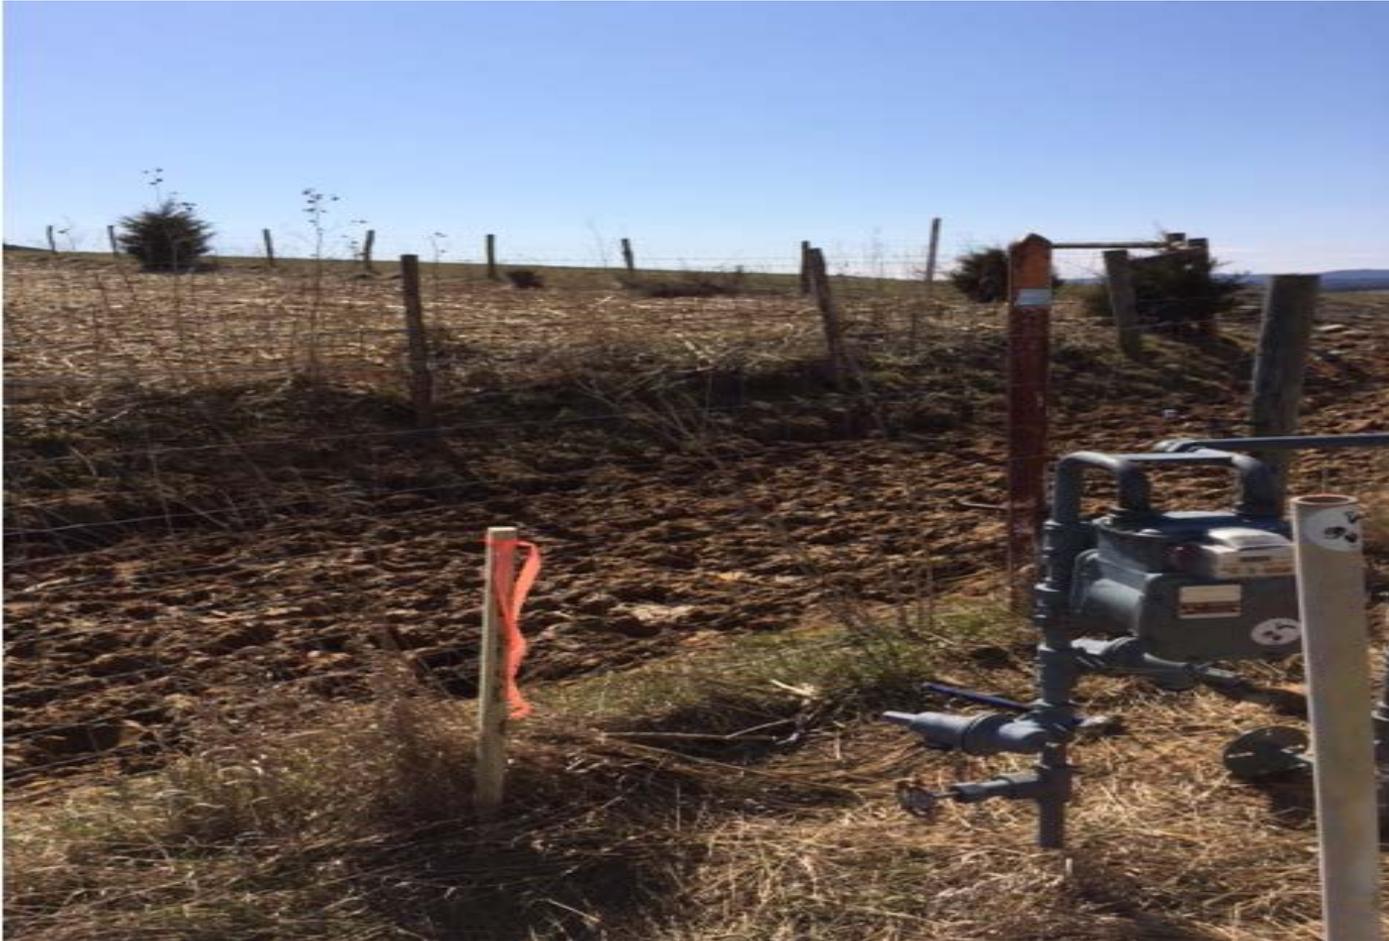
Erosion/Other “Cow Crossing”
