Underground Utility Damage Case Studies

Paul Gendron
Virginia State Corporation Commission
Division of Utility and Railroad Safety

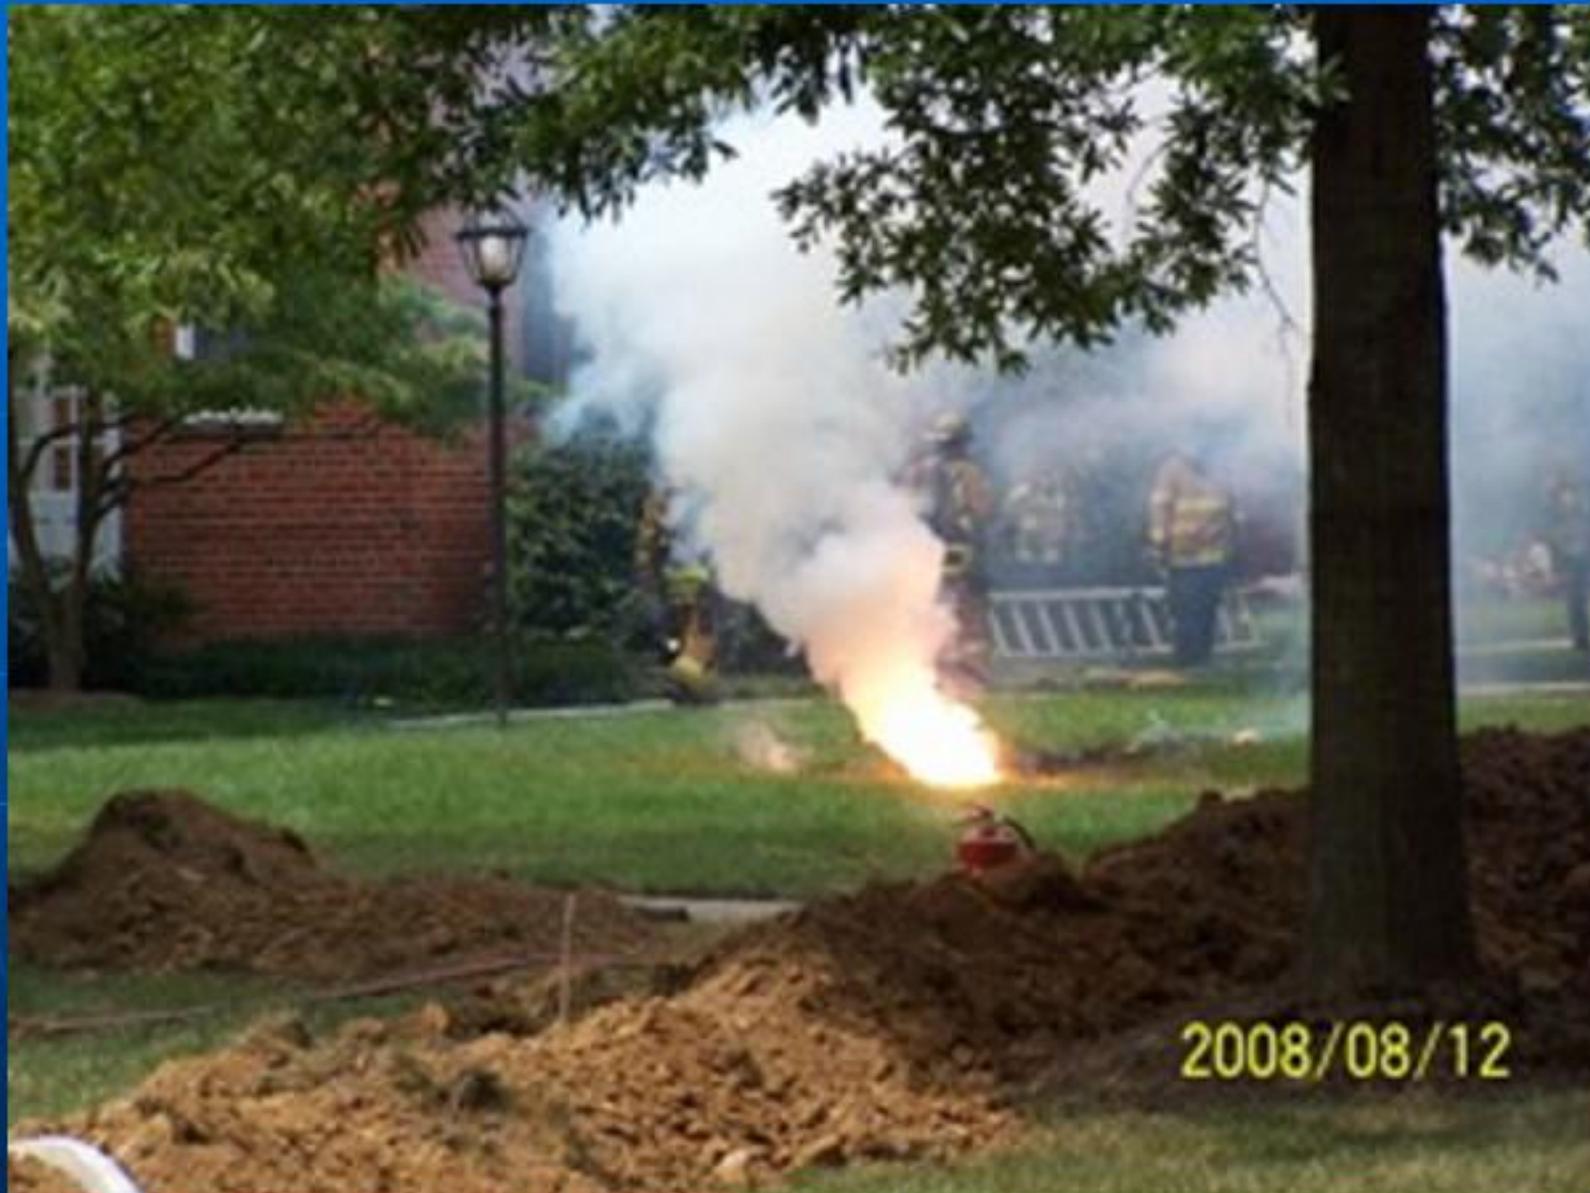
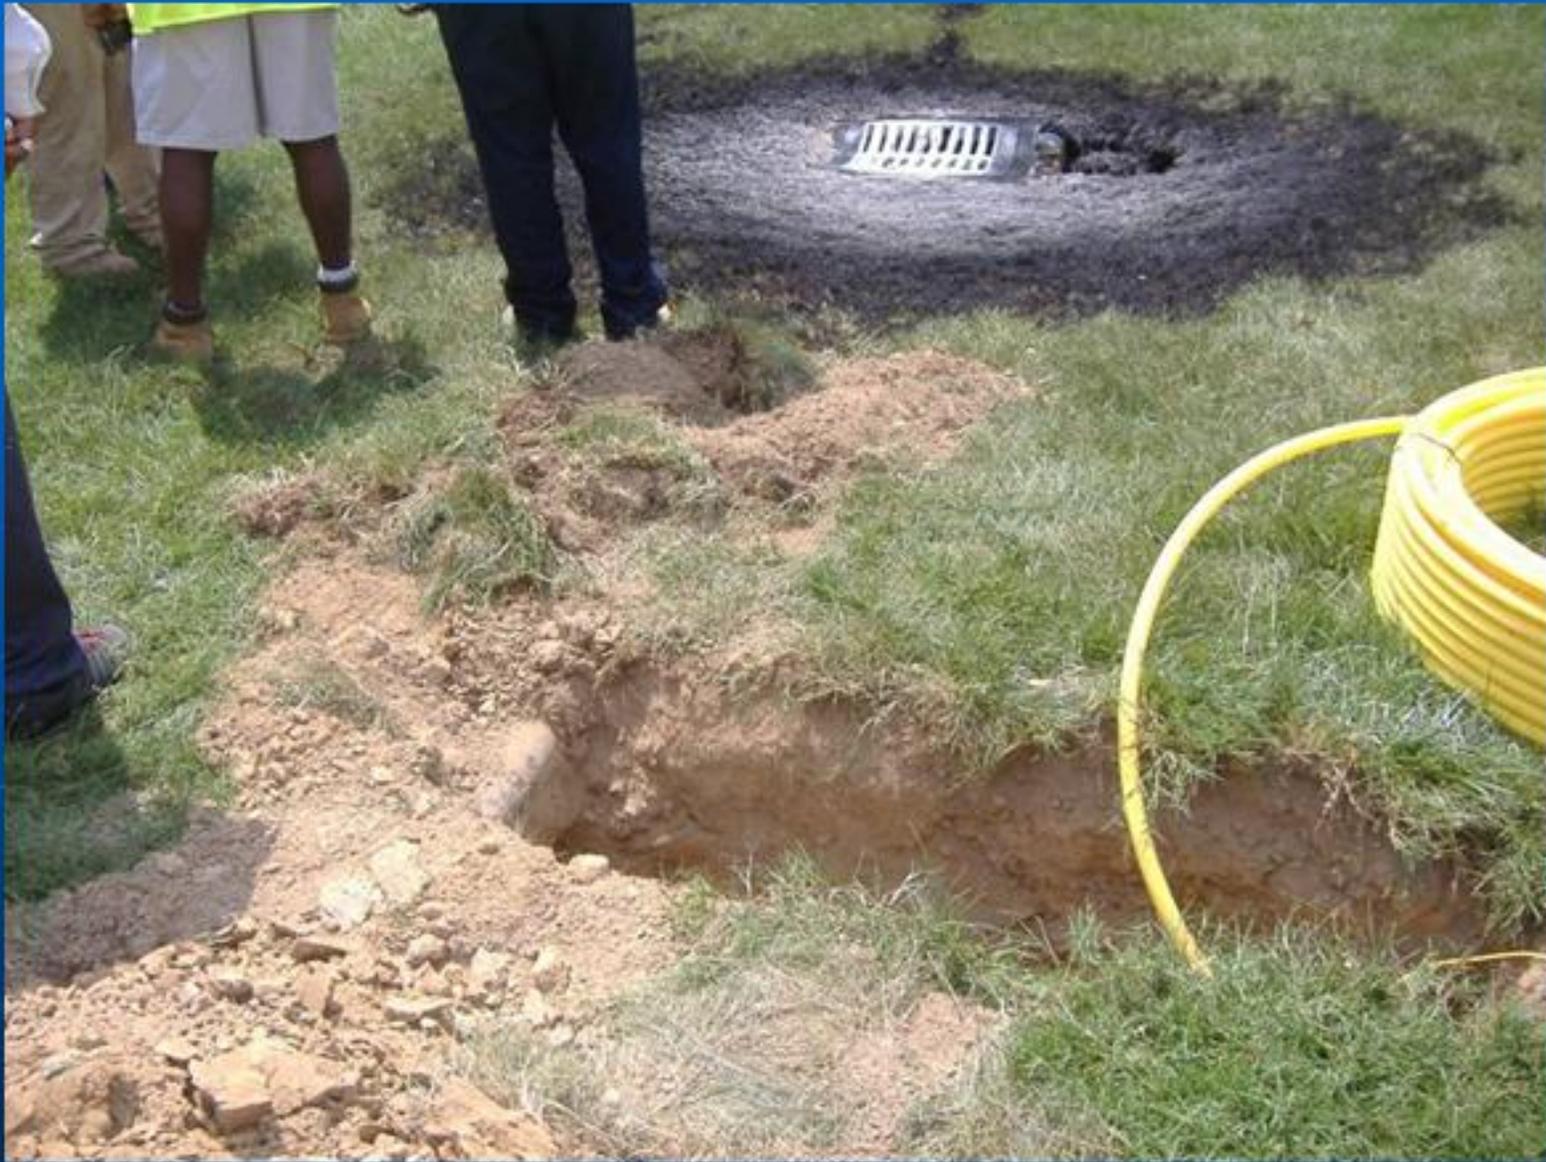
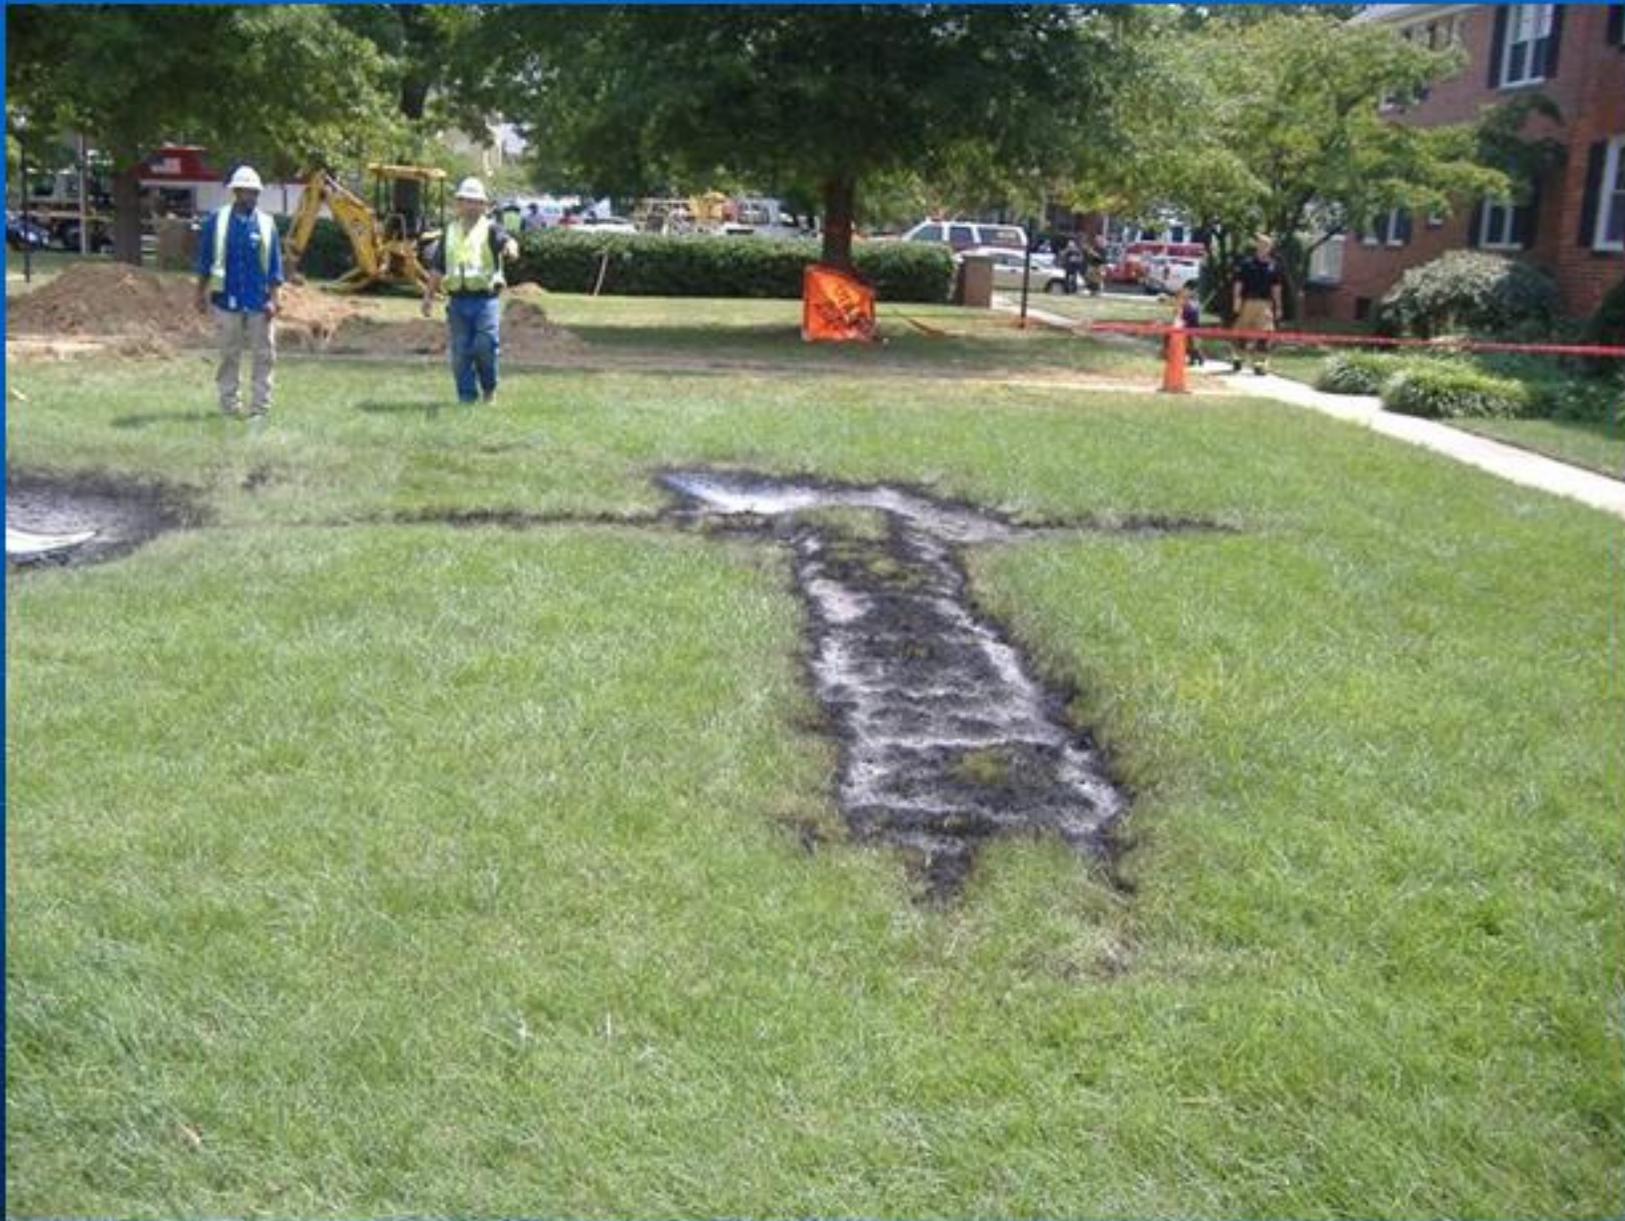
Damage: Electric Secondary

- Background: Contractor was replacing gas services at an apartment complex and struck an electric secondary. The contractor had a valid ticket and was crossing the secondary for the fourth time when it was struck. The secondary was not marked and the ticket response for power was a code 30.

- Service records for the area were not available to guide the locator
- Locator did not sweep properly as per procedure

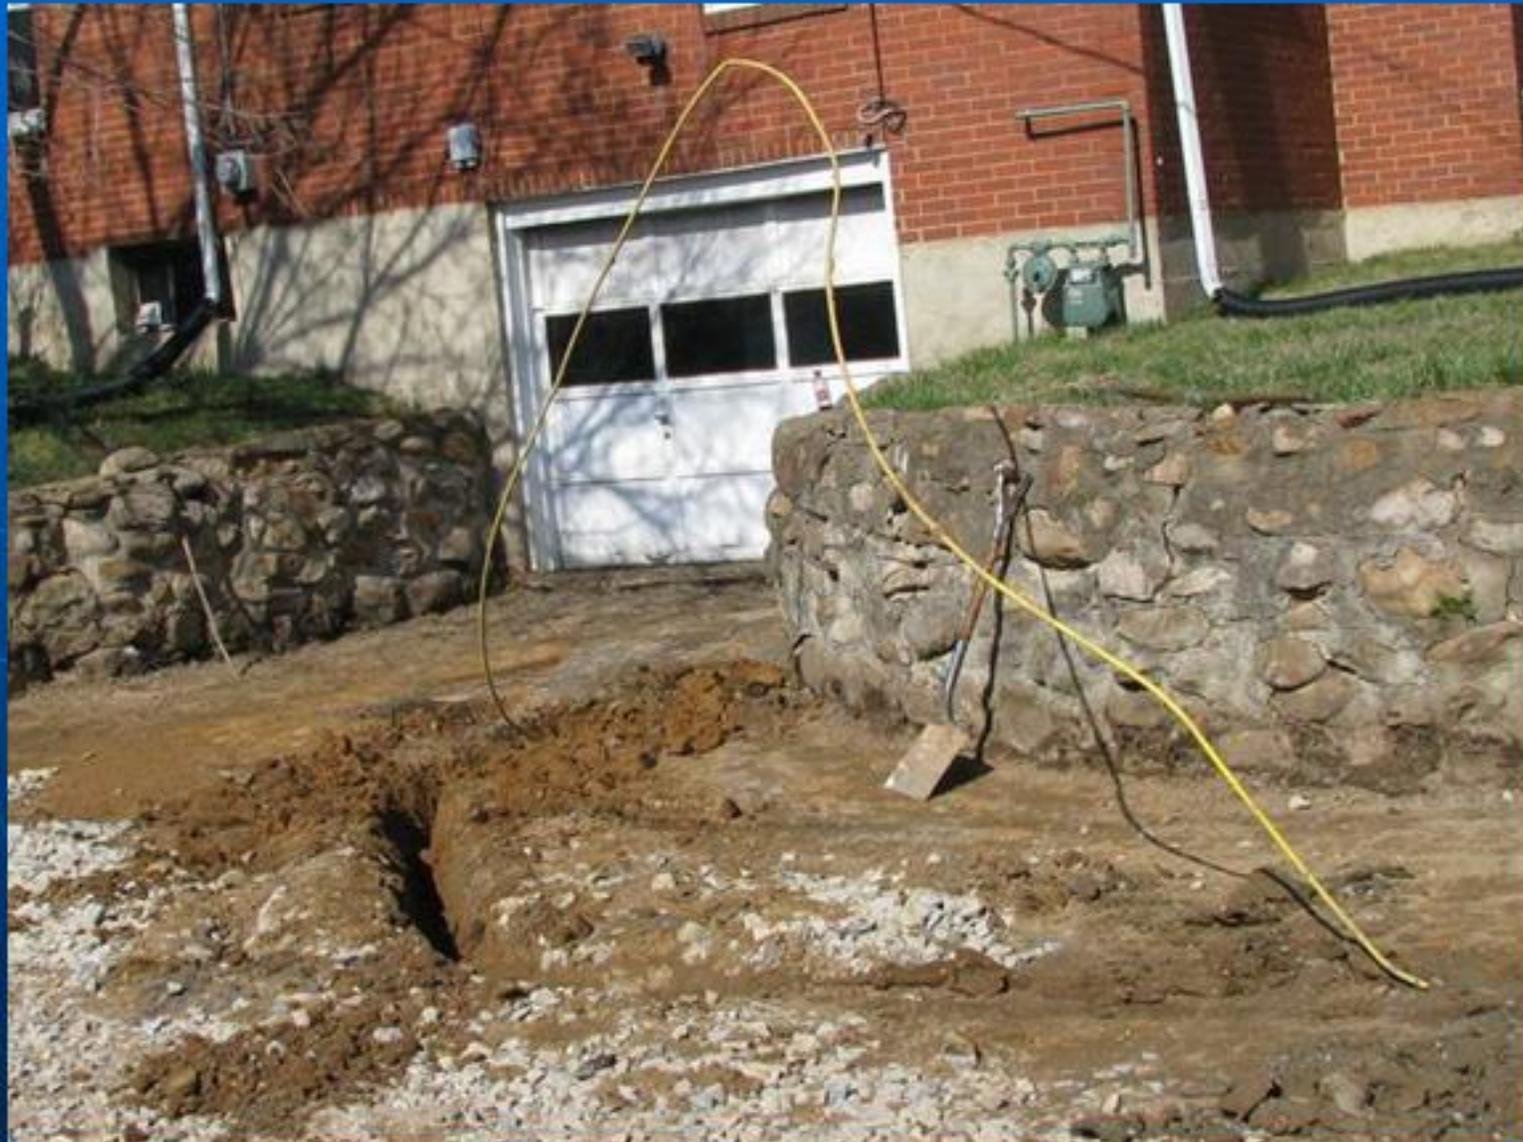
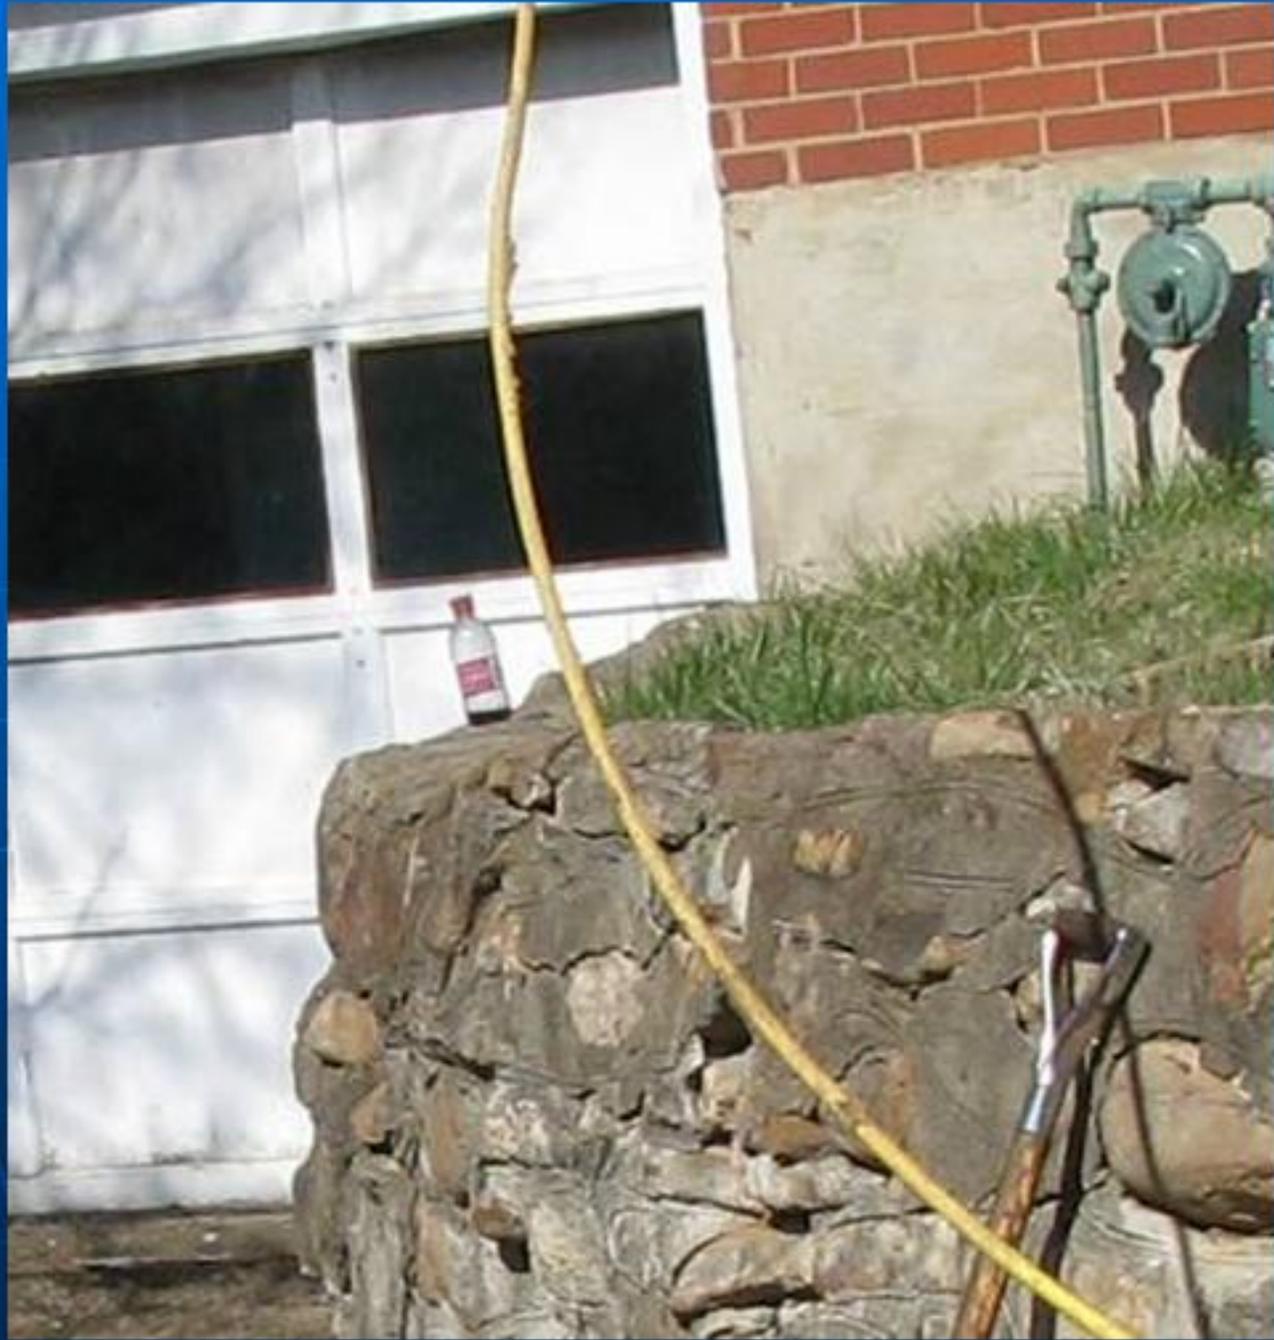
Unsupported Gas Line

- Background: A paving contractor was grading for driveway paving with a skid steer loader, and scraped a coated steel gas service line. After discovering it, the contractor unearthed the line and failed to support it properly. The contractor then decided to relocate the line, and dug a trench for the relocation. Before the contractor was able to rebury the line, he damaged it in another area, resulting in a leak.

- Contractor did not contact the operator after damaging the coating on the utility line
- Contractor did not properly support or protect the exposed utility line
- Contractor did not receive authorization from the operator to relocate their facility and intended to backfill without contacting the operator.

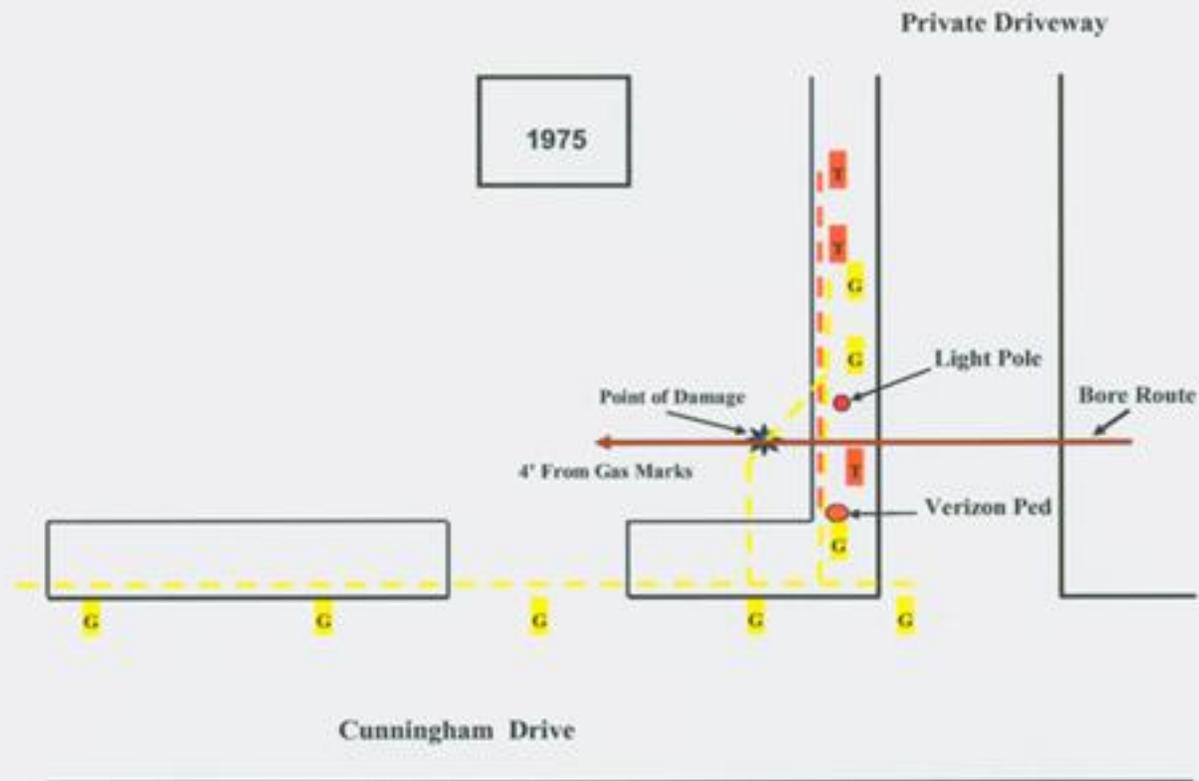
Sketch of Damage Area

- Background: A contractor was boring in streetlight power lines and struck a gas service line. The line was marked in accordance with the service records and the strongest available signal, yet inaccurately.

- Operator's service card inaccurate
- Locator bled over onto a communications line that ran in close proximity to the gas line and in accordance with service card
- Excavator attempted to expose the line and could not find it. Excavator assumed it was deeper than they needed to bore and chose not to call in a three hour notice to confirm marks.

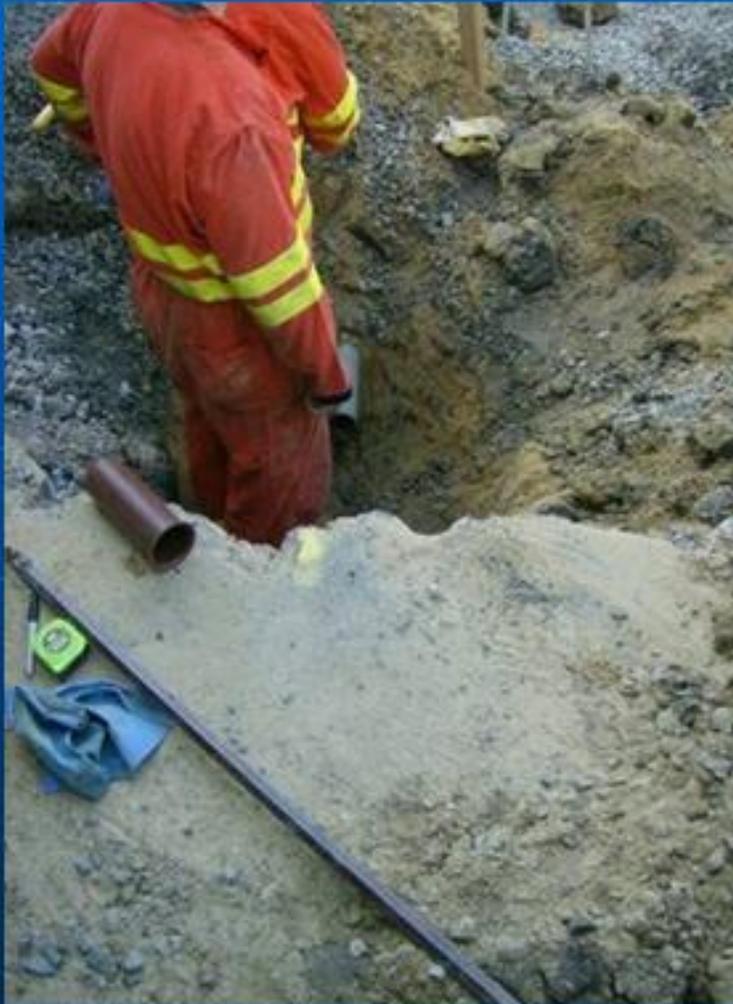
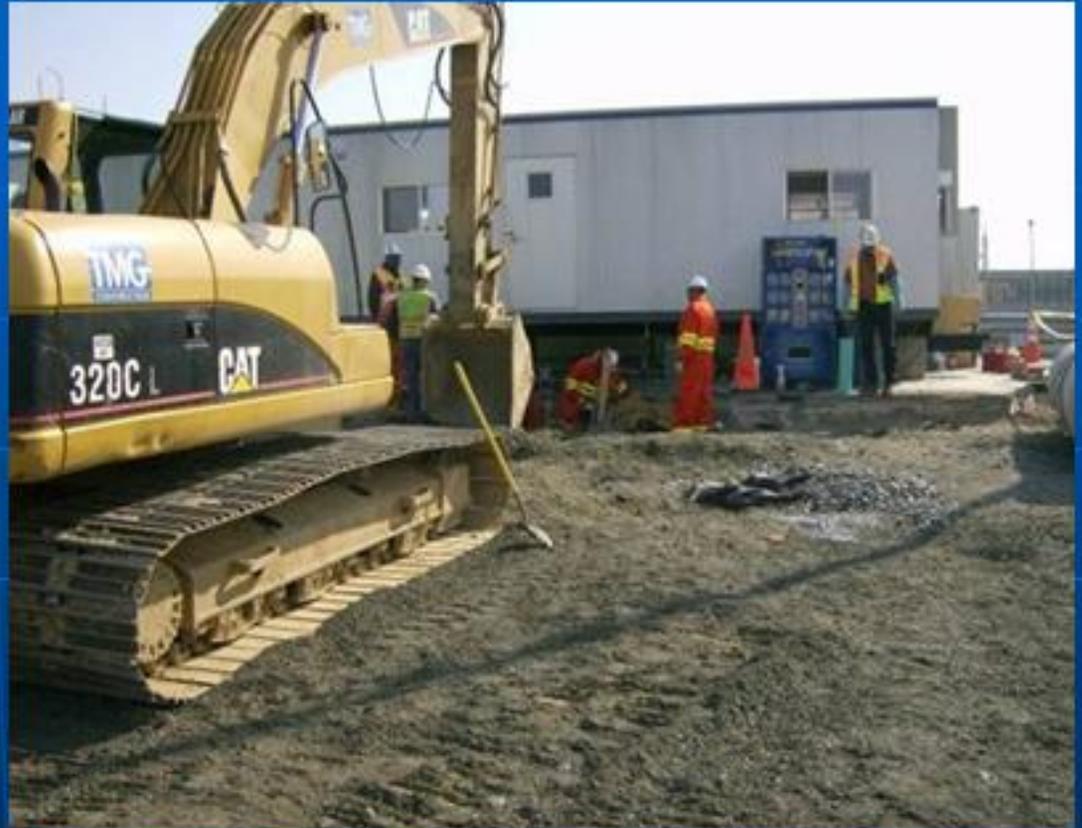
- Background: A contractor was excavating to install a concrete storm drain at Reagan National Airport, and punctured a 3" gas main. The damage required that 60 people be evacuated from the area and caused flights to be delayed. The gas main was located accurately by a private utility locator. The excavator did not call Miss Utility prior to the excavation, and was using a large excavator to break through asphalt and cement aggregate when the damage occurred.

- Excavator hired a private locator that was not qualified by the gas operator, instead of calling Miss Utility as the law requires
- Excavator used a large tracked excavator to aggressively break through asphalt and concrete reinforced aggregate

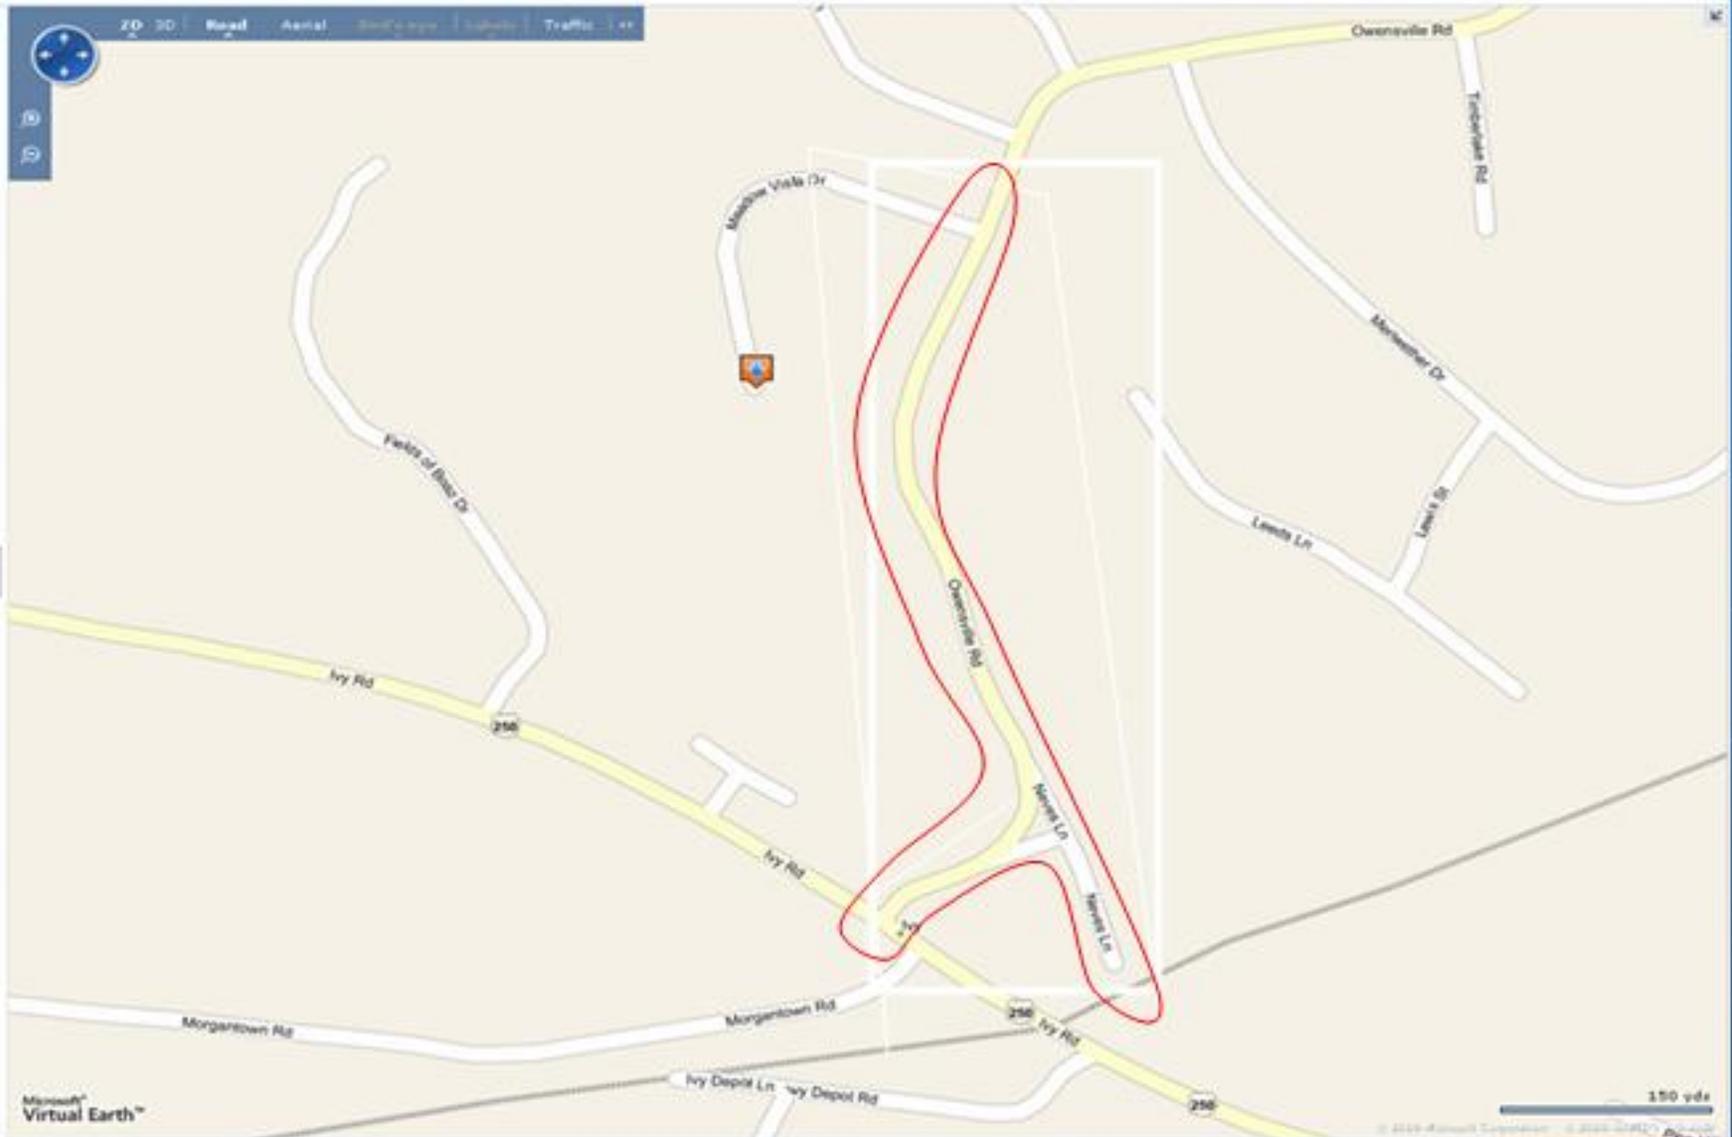
- Background: A municipal water operator had to re-route a water main installation, at an approximate cost of \$100,000, due to an alleged unmarked communications line. The operator's installation designer called in a regular ticket for the initial survey and geotechnical boring, and did not utilize a designer ticket. A year later, when the water main installation commenced, the installation subcontractor had a conflict with marked communications lines that weren't marked on the ticket for the initial survey.

- Design Contractor did not utilize a designer ticket for purposes of installation design. Instead they relied on a normal ticket for geotechnical boring to do the initial site survey
- The scope of the initial ticket was different from that of the ticket for installation, and did not encompass the communications line that was marked on the installation ticket.
