Construction Inspection

Gas Distribution System Growth in Virginia

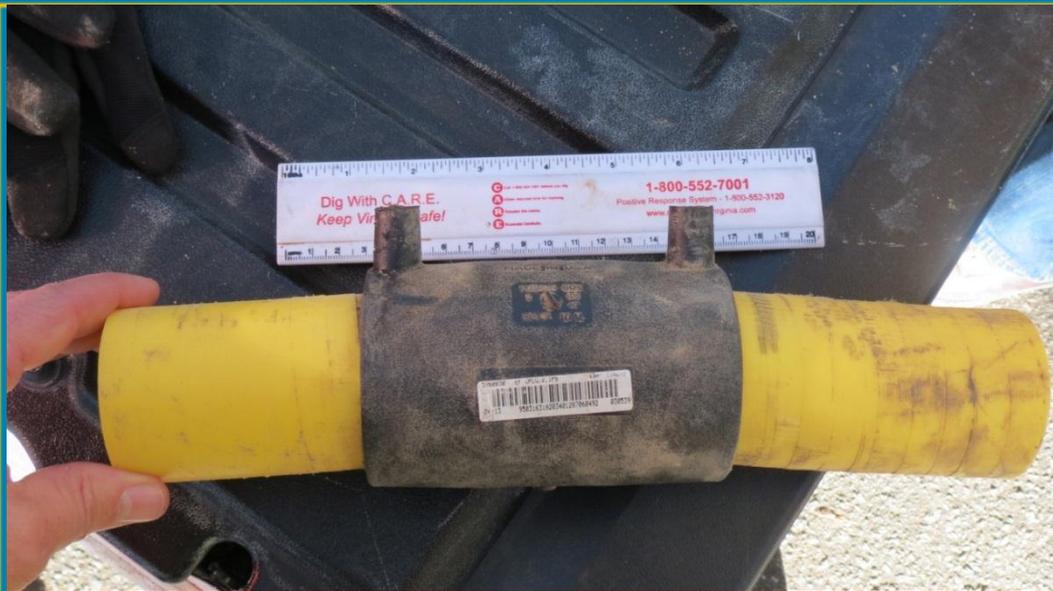
§ 192.273(b) - Failure of the Company to follow written procedures that have been proven by test or experience to produce a gas tight joint by not verifying the correct insertion depth on both ends before starting the electrofusion process.

§192.305 - Failure of the Company to inspect a main to ensure that it is constructed in accordance with Company's O&M procedures developed to comply with §192.273(b).

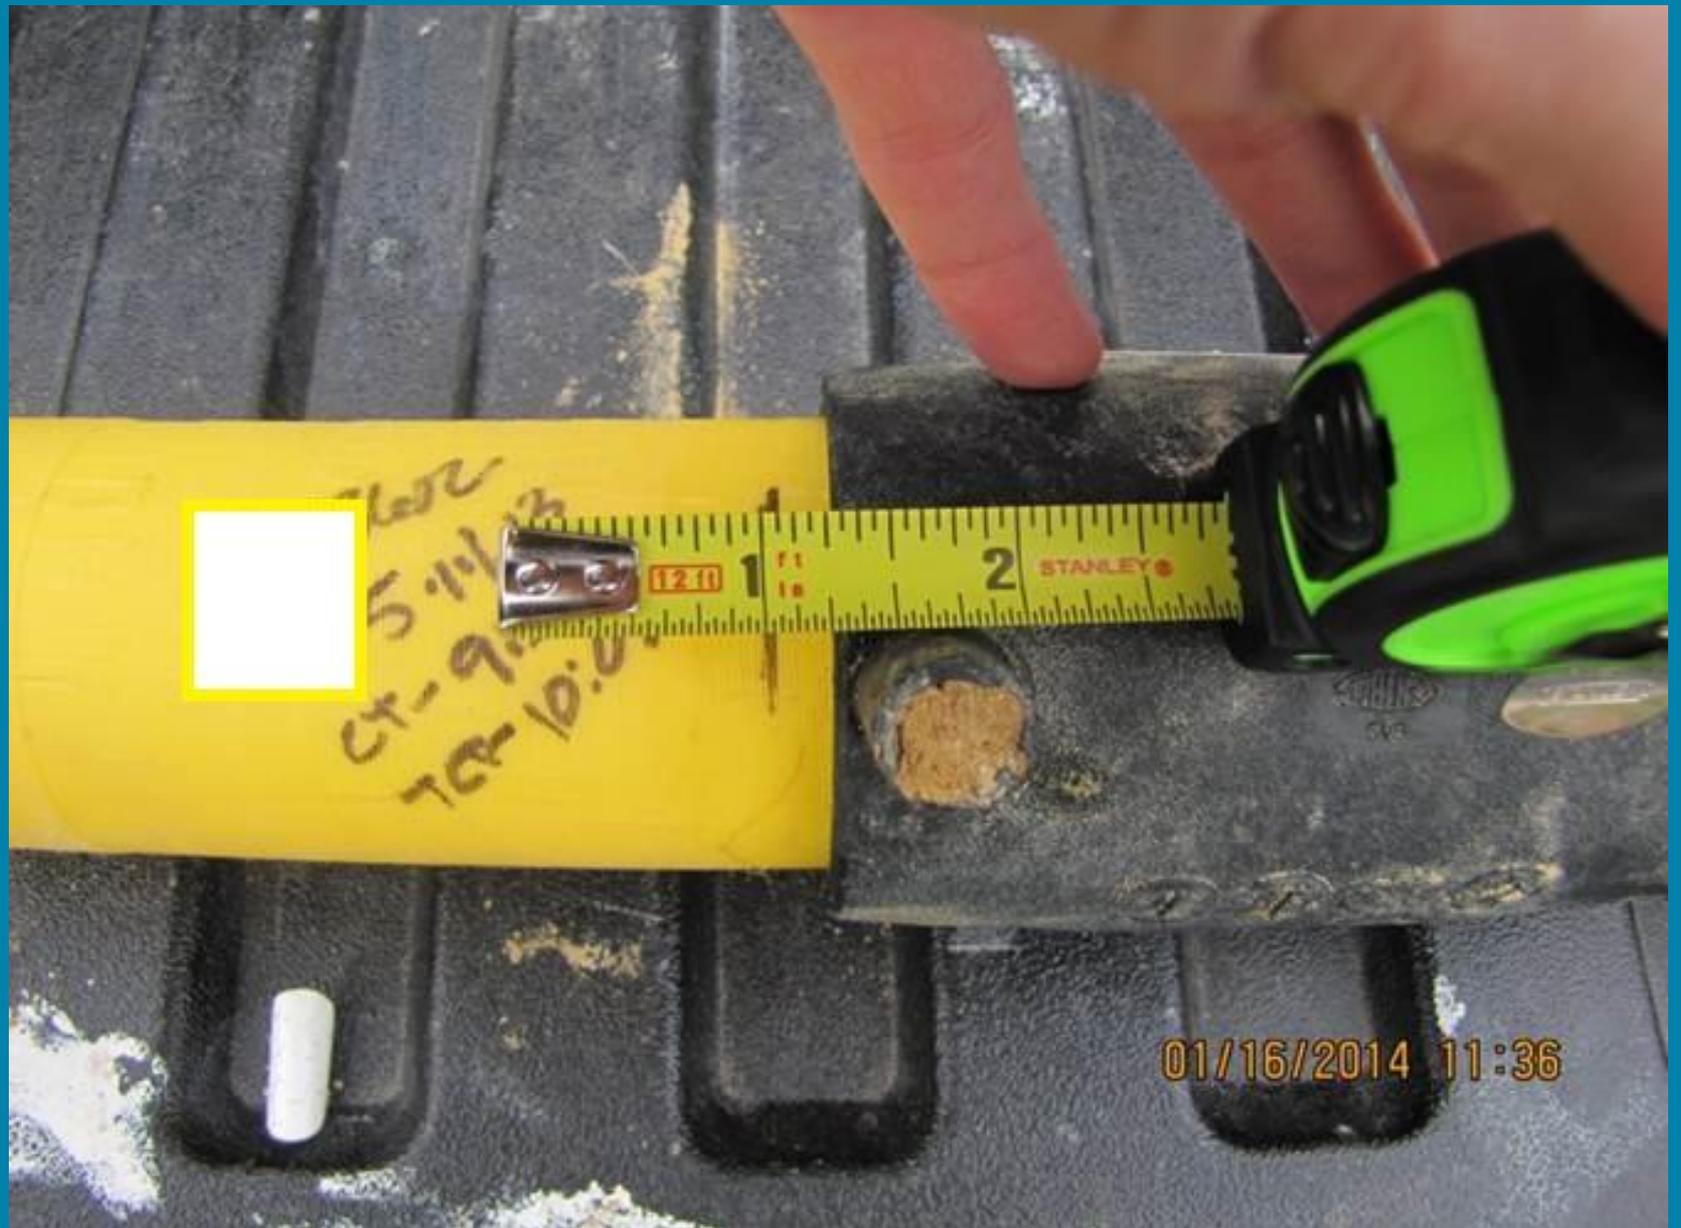
1652
5-11-13
CP-910
TCP-10:0

§ 192.273(b) Failure of the Company to follow written procedures that have been proven by test or experience to produce a gas tight joint by not verifying the correct insertion depth on both ends before starting the electrofusion process.

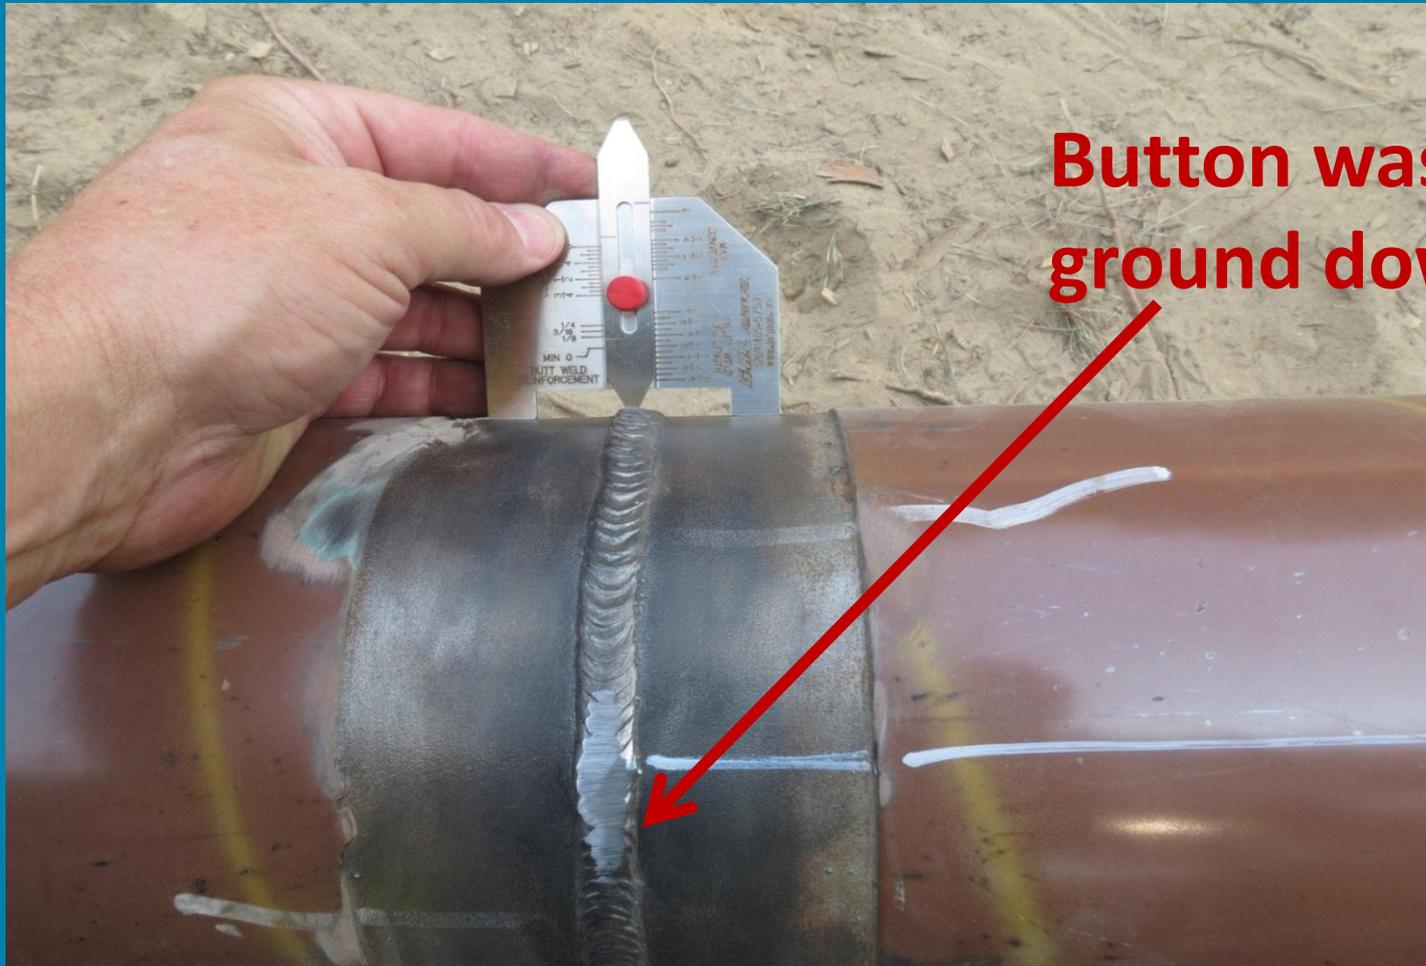
§ 192.235- Failure of the Company to preserve the alignment while the root bead is being deposited.

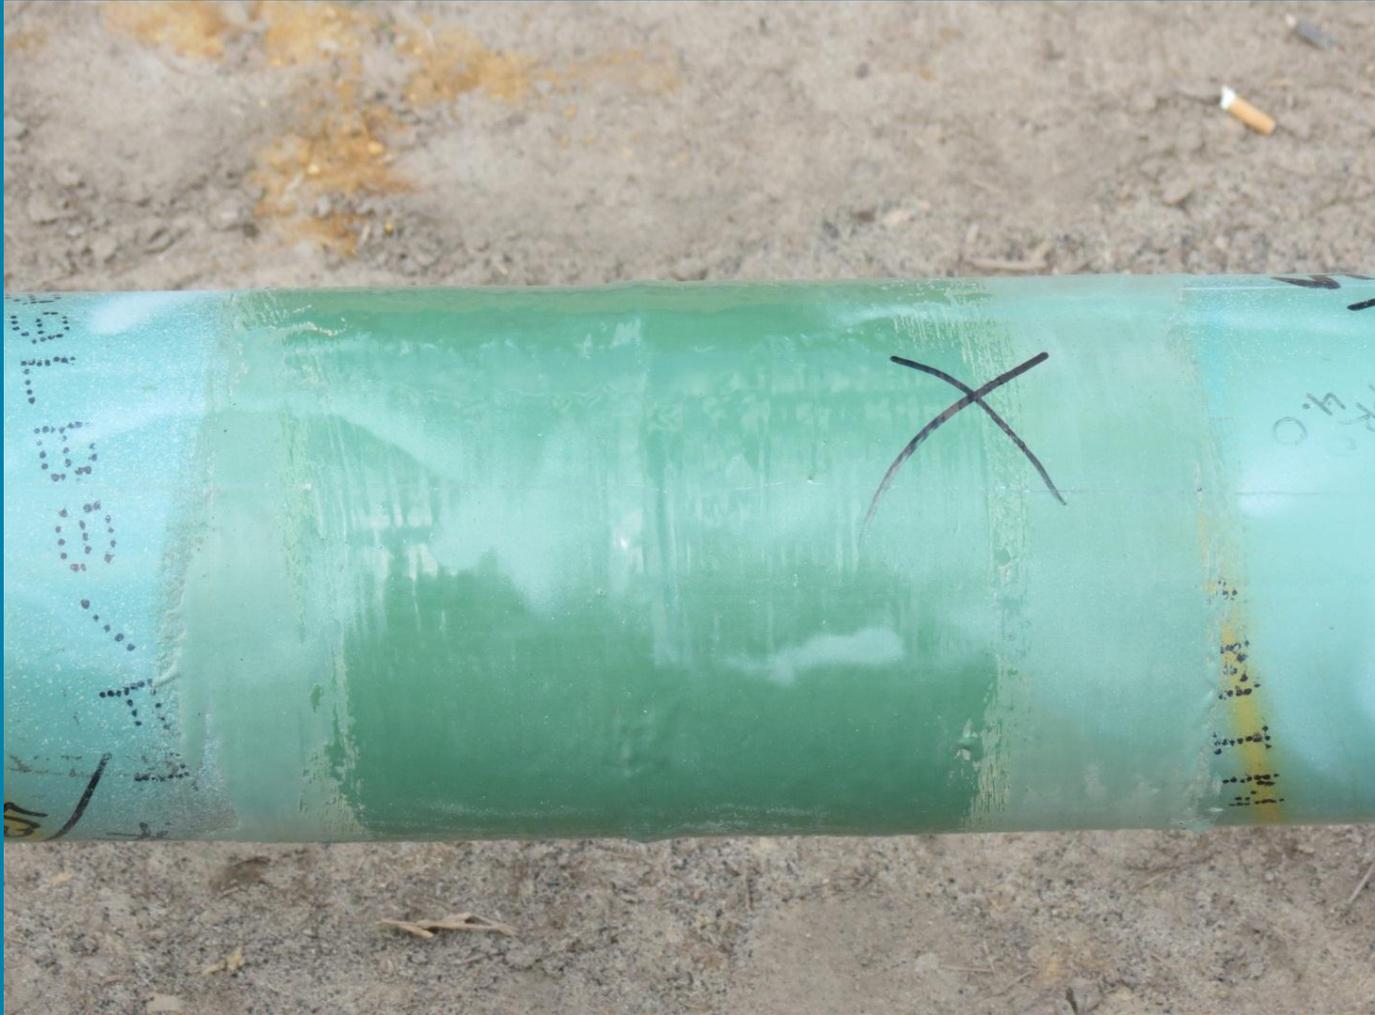
Coating issues

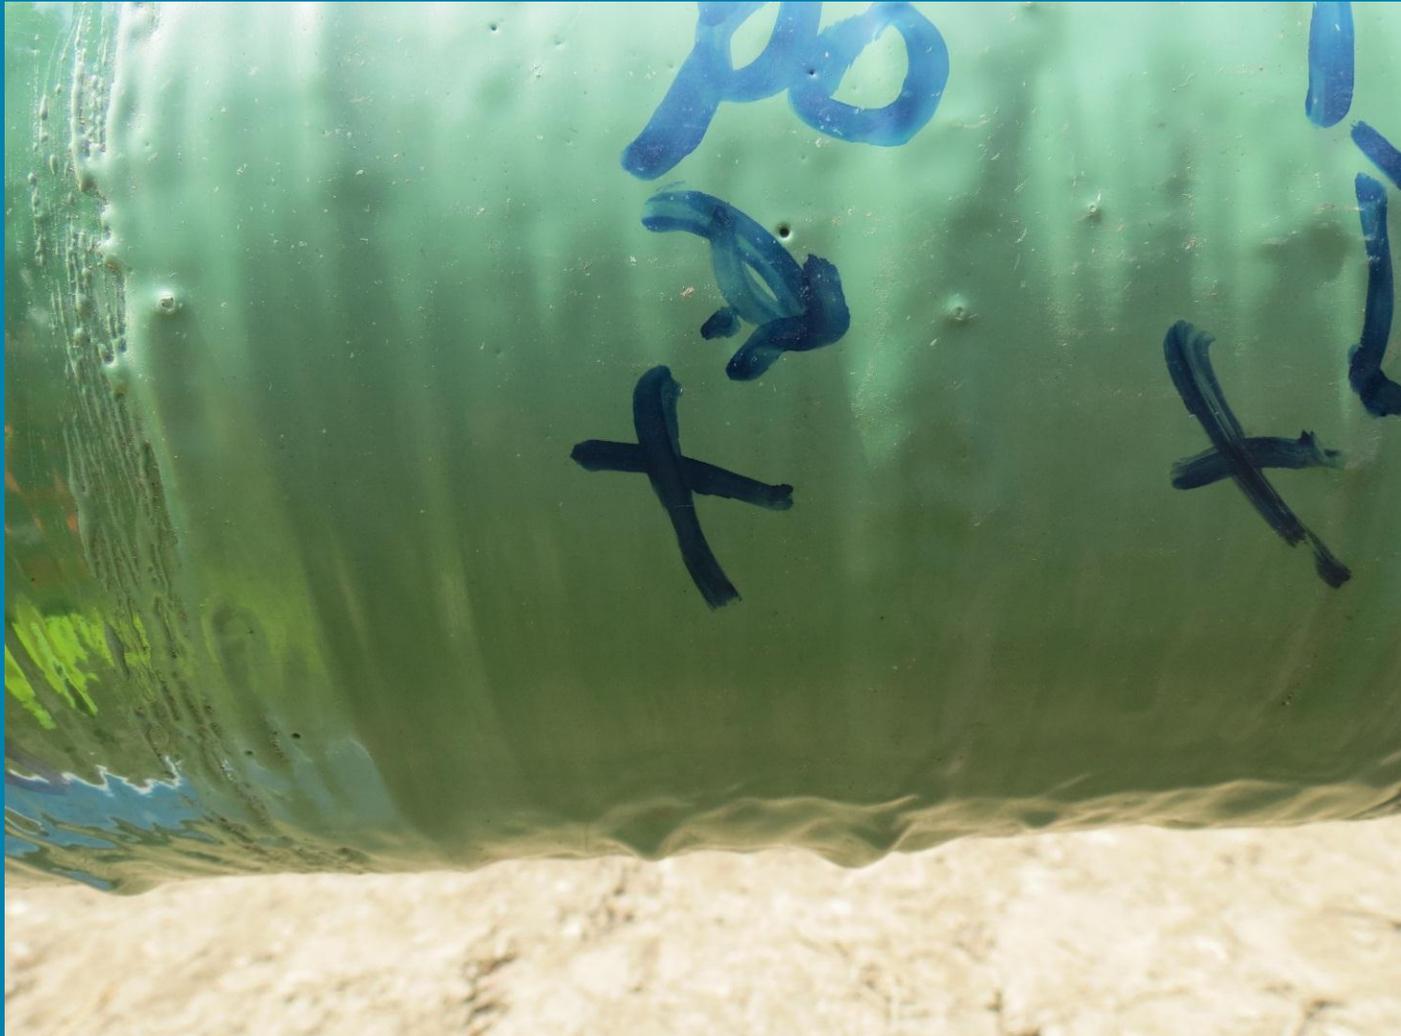
189.5 mills

Example: 2 coats would be 100 mils total thickness, 30 mils greater than recommended.

The Company inspector interpreted this as 50 mils per coat.

Understanding the manufacturer's procedures when they are referenced in the Operator's O&M. Get clarification when there is more than one interpretation.
