New Technologies for Damage Prevention

Ashley Donnini, NiSource
Alicia Farag, GTI

Columbia's GPS Pilot Project

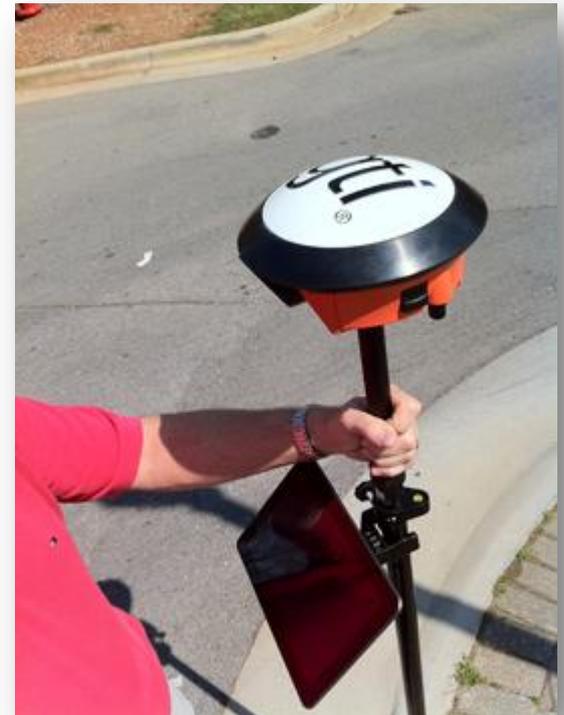
High Accuracy GPS

- > Integrated external high accuracy GPS receivers with tablet computers
 - Sub-foot quality data in real time
 - No need for post processing or a base station
 - Field data directly inserted into the GIS (with controls)
 - Integrated receivers, so far . . .
 - > Navcom
 - > Geneq
 - > Trimble

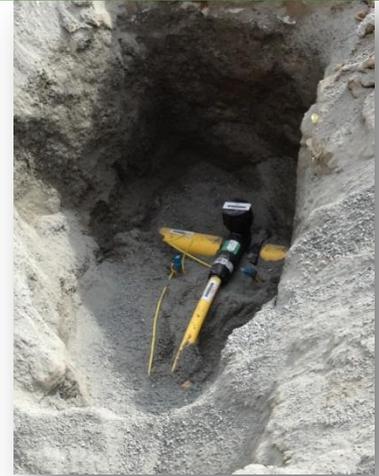
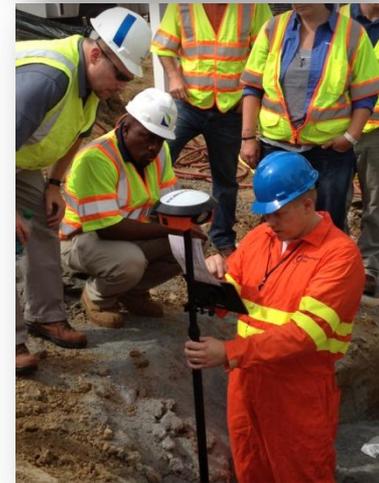
- > GTI's technology solution
 - Barcode scanner
 - High accuracy GPS receiver
 - Tablet device with GIS-based data collection software
 - Application to convert barcode into asset attributes to auto populate the GIS
- > Pilot projects
 - NiSource, Integrys, Avista

- > Automates the entire data collection process for documenting new installations
- > In less than one minute . . .
 - The barcode scanner captures asset attribute information and causes a new feature to be created in the GIS
 - GIS fields are automatically populated with asset attribute information (material type, batch number, etc)
 - The location of the new asset is positioned with the sub-foot accurate GPS in real time
 - Data is available in the back office immediately

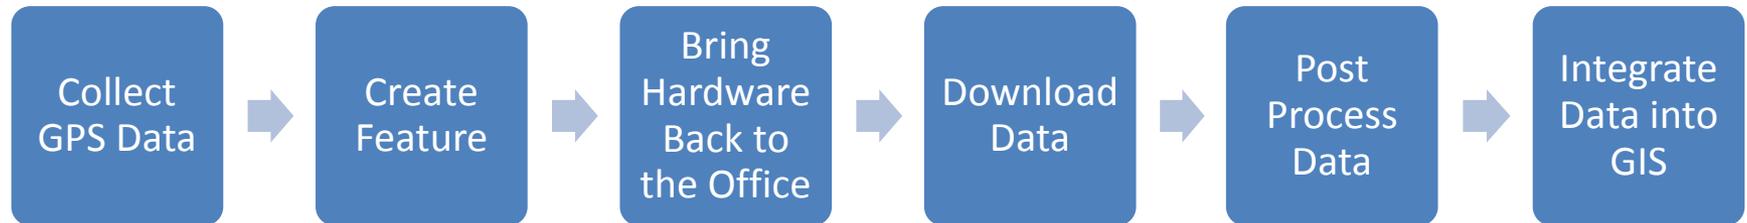
> Existing

Data Collection Workflow

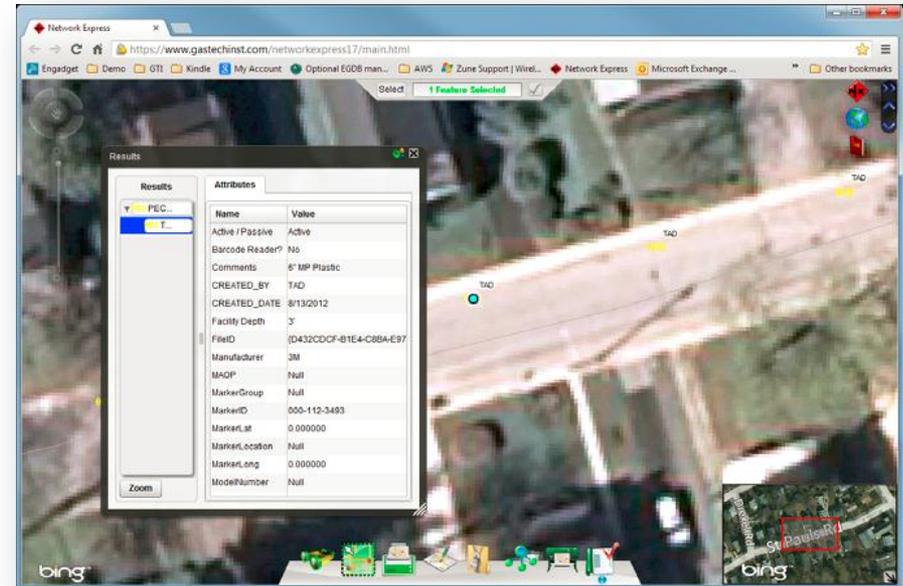
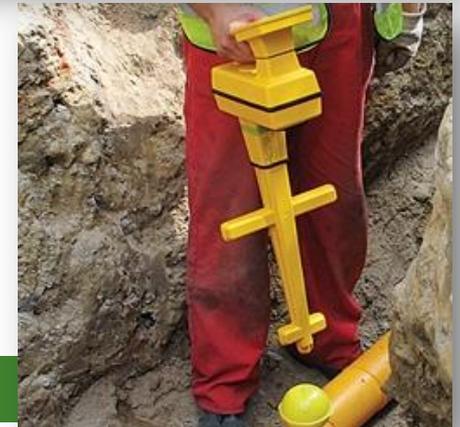
- > GTI's marker ball mapping application
 - Create new marker ball features in the GIS from the field
- > Pilot projects
 - PECO
 - ConEd

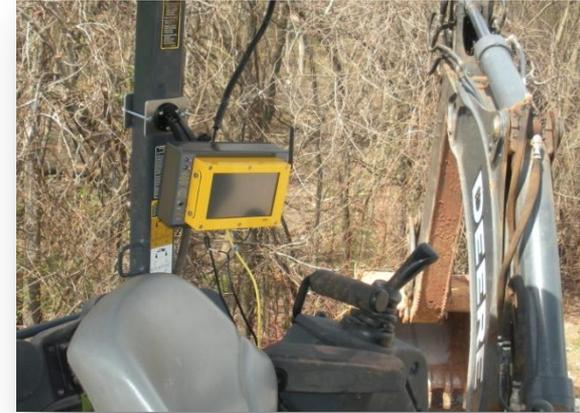
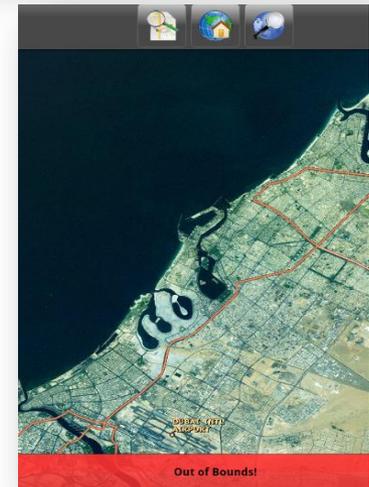
- > GPS tracks excavation activity in relation to assets and one-call tickets
- > Provide real-time notification of encroachment
- > Modifications to original system
 - GIS-based
 - Smart phone monitoring
 - Alternative GPS options
 - ROW monitoring

- > New pilot project in New York
 - High accuracy GPS for excavators and pipe locations
 - Application - DOT projects
- > Developing pilot projects in California and Texas
 - Lower accuracy GPS tracking
 - ROW data in the GIS for pipe locations
- > Bring the system that Dave Thompson envisioned back to Virginia!

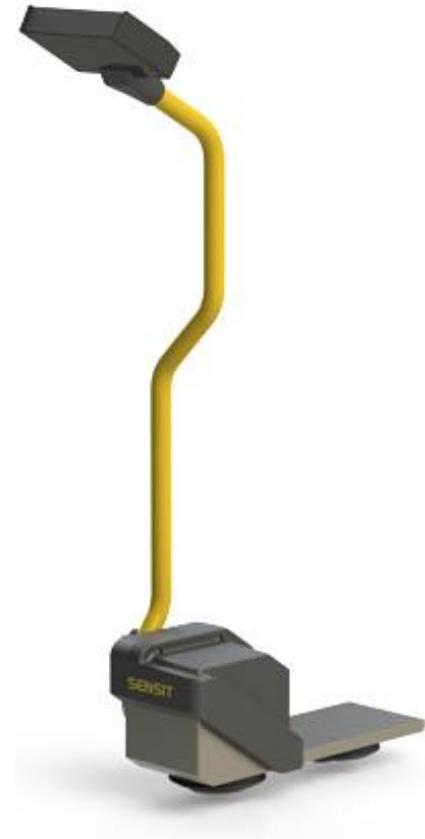
- > Locates plastic pipe with no tracer wire
 - ½” pipe up to 30” deep
 - 4” pipe up to 96” deep
- > Commercialized as Ultra-Trac[®] by Sensit Technologies

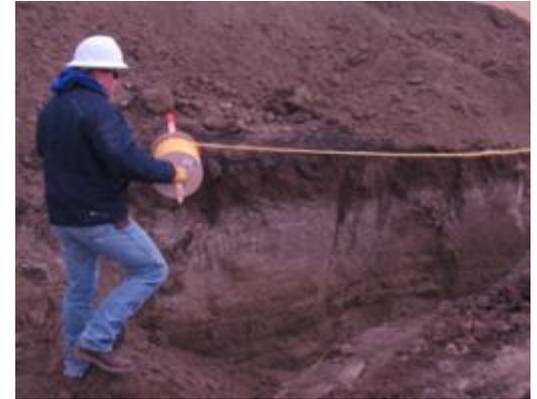
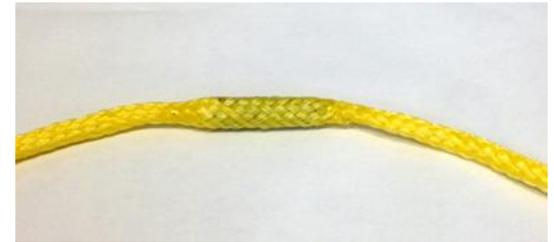
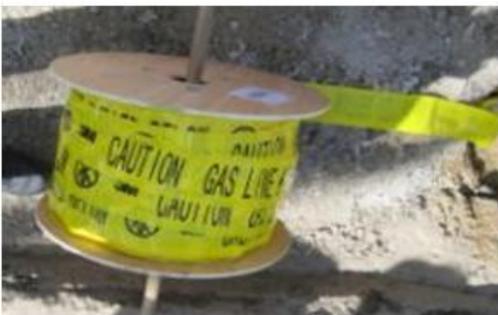
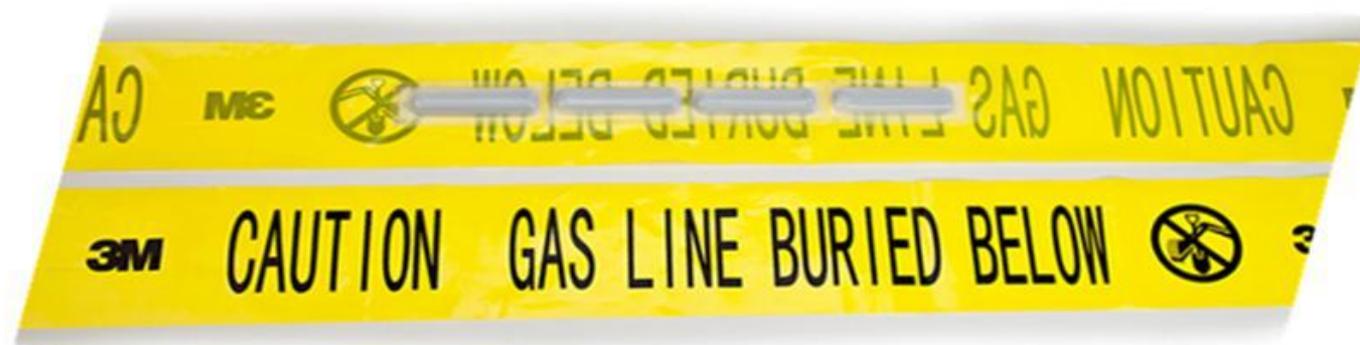
- > 3M's solution for tracer wire issues
- > GTI testing and implementation support
- > New solution for HDD

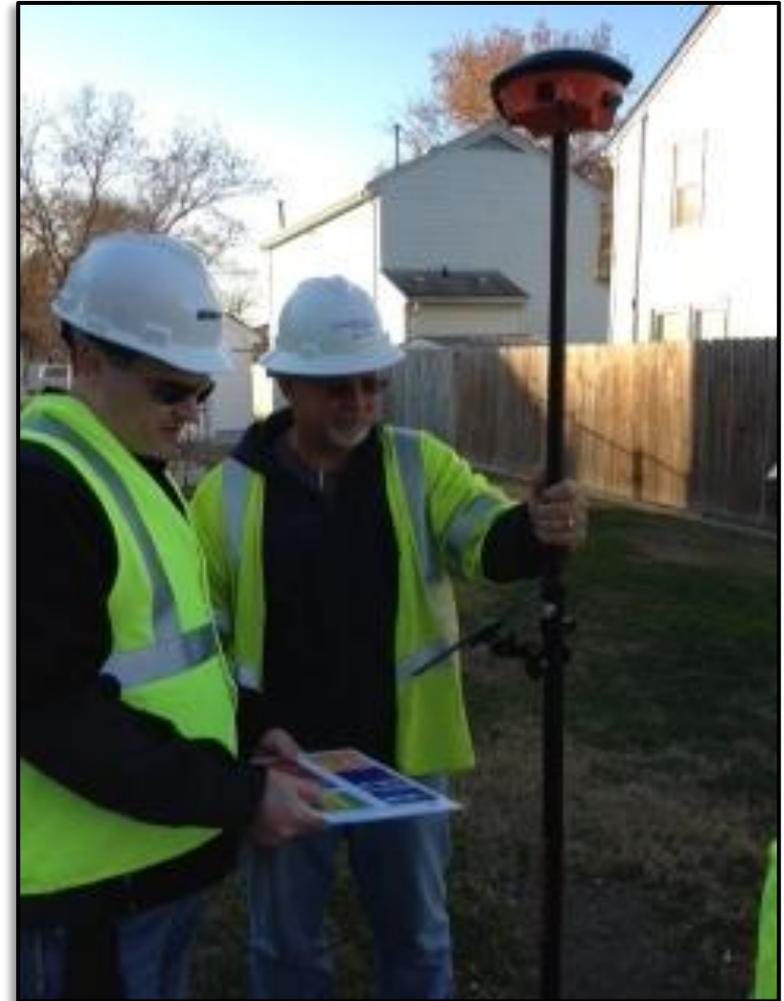
- **Appears to maintain a baseline visual spatial accuracy**
- Closer inspection shows position discrepancies, overshoots, undershoots, gaps and junk records
- Will need validation of accuracy of points collected in future pilots while considering alternate means when coordinate cannot be collected.

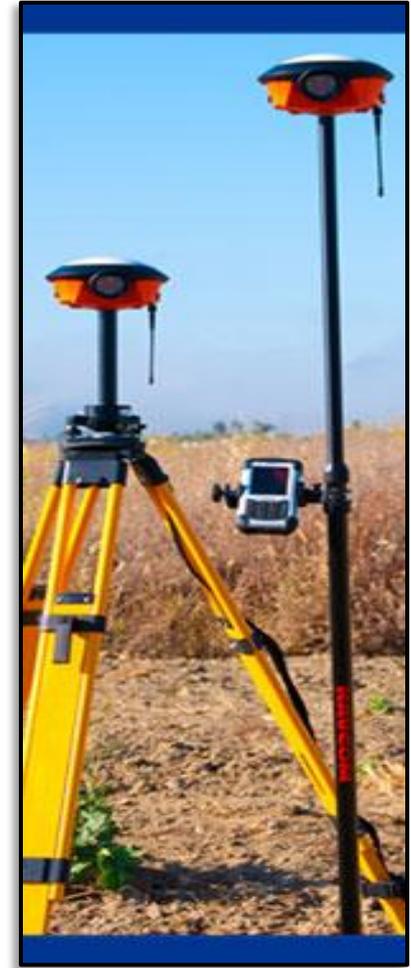
- ***Key Points:***

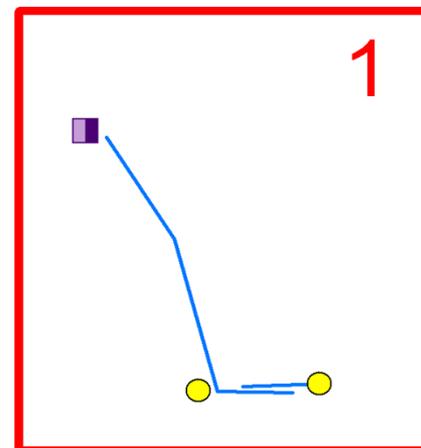
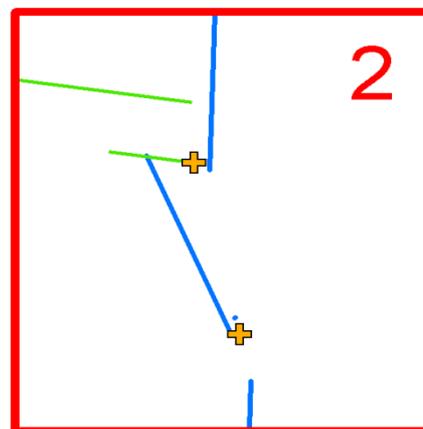
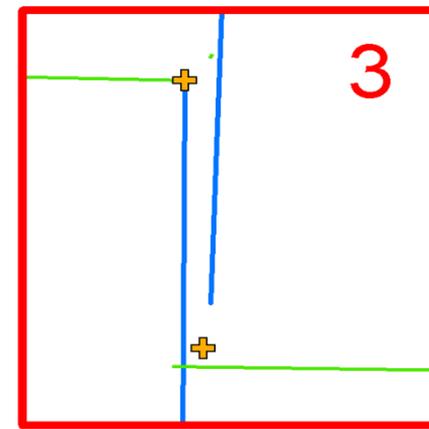
Spatial Quality Assessment

- Independent visual reference sources:
 - NiSource GIS landbase
 - ROW
 - Road Centerline
 - Gas Main Line
 - VGIN 2008 statewide orthoimagery

Over time, may necessitate an upgrade of our landbase maps

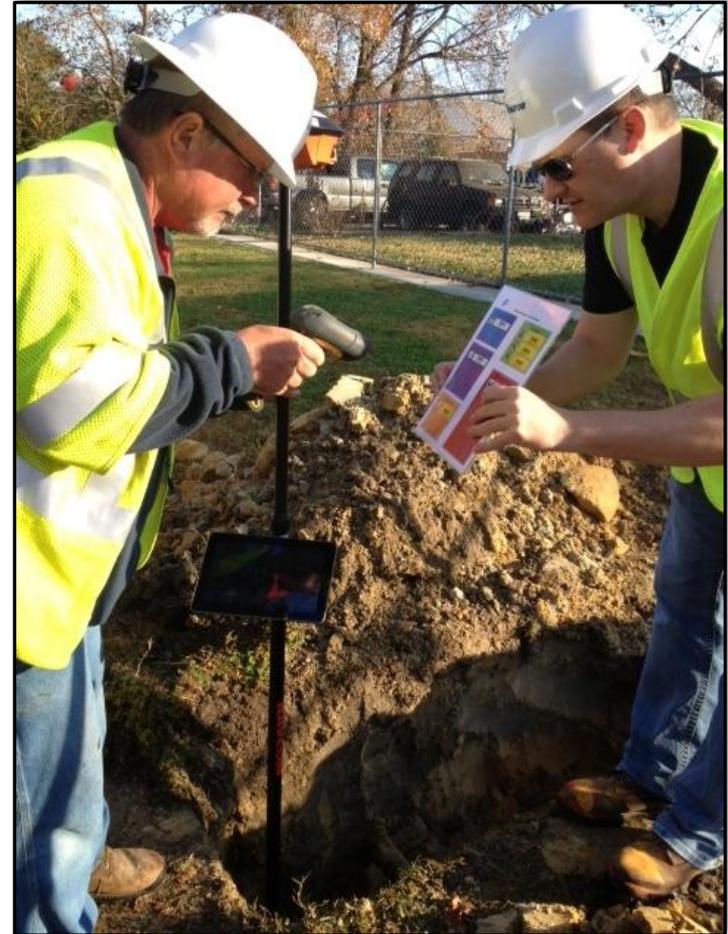
- **GPS Lock**

- Buildings, tree canopy, other obstruction
- Frequently experienced
- Software freeze/crash

- * ***Higher sensitivity antennae***

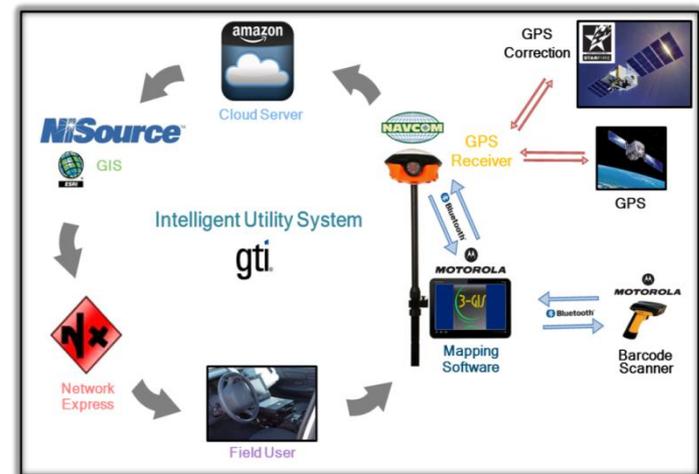
Connection Issues

- **Wireless connection**
 - Availability
 - Software freeze/crash
 - * ***Disconnected version***
- **Barcode Scanner Connection**
 - Variable success depending on tablet configurations
 - Reconnect button create crash
 - * ***Stabilize and explore alternatives***

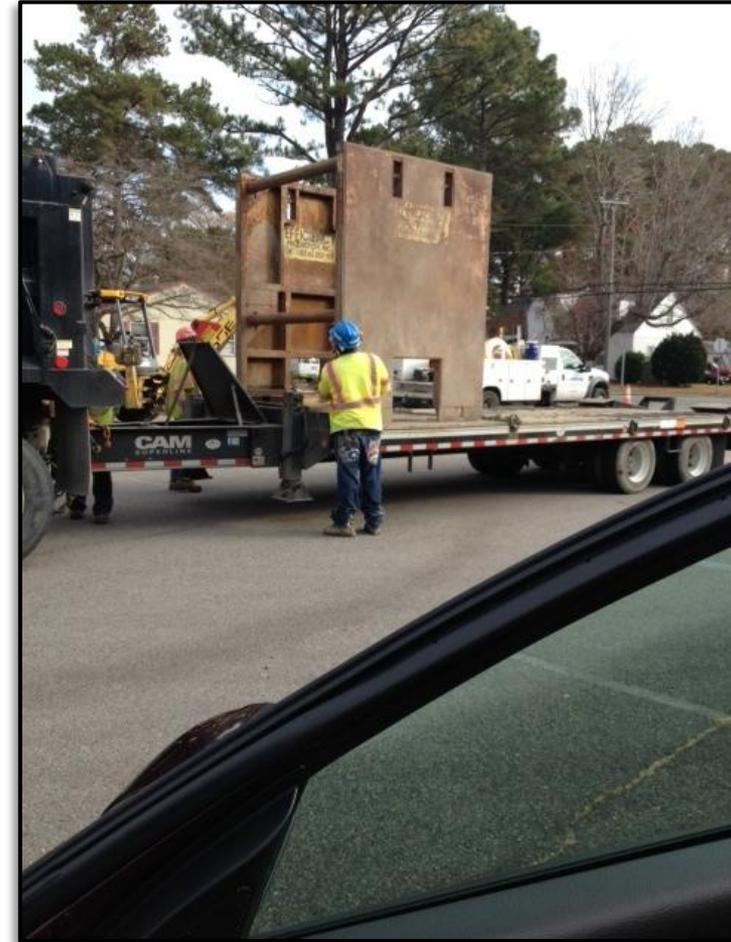
Environmental Conditions

- Environmental conditions were observed to be a factor in performance:
 - Precipitation
 - Extreme cold
 - Extreme heat
 - * ***Try to mitigate as best possible; realize that weather will at times prevent collection***

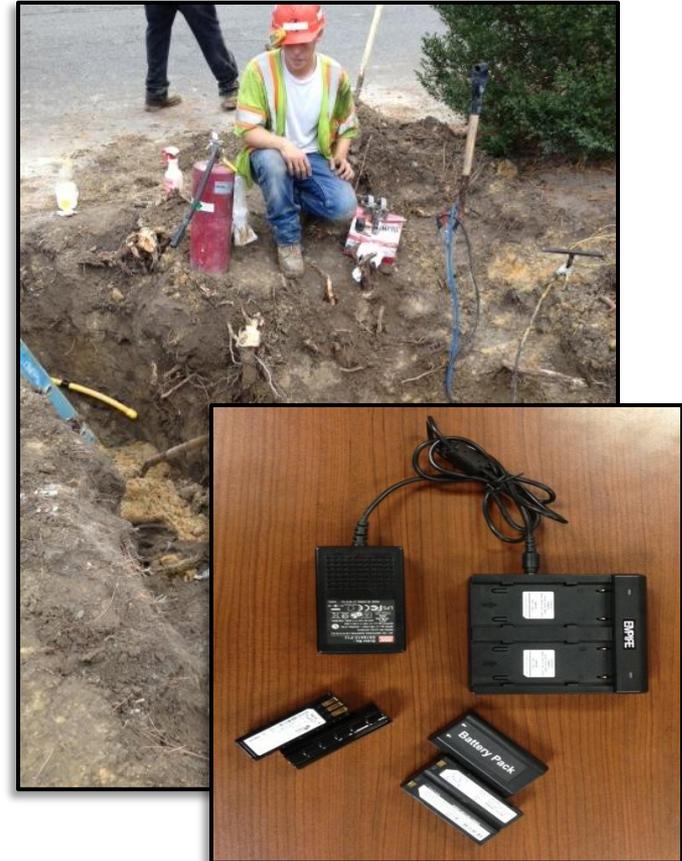
- **Key Points:**
 - Both non-operational and operational challenges
 - **Exploring solutions like ground stabilization, receiver options, weight, etc.**
