Construction Inspection

Gas Distribution System Growth in Virginia

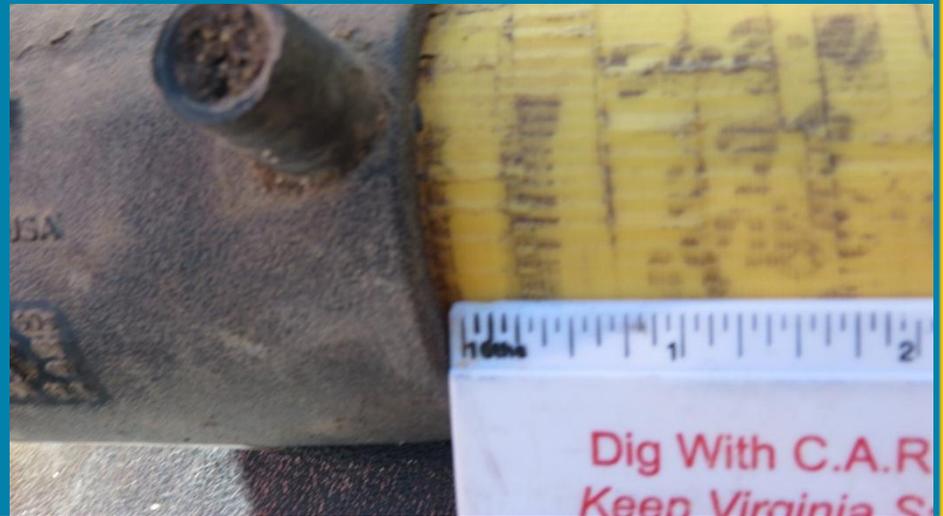
§ 192.273(b) - Failure of the Company to follow written procedures that have been proven by test or experience to produce a gas tight joint by not verifying the correct insertion depth on both ends before starting the electrofusion process.

§192.305 - Failure of the Company to inspect a main to ensure that it is constructed in accordance with Company's O&M procedures developed to comply with §192.273(b).

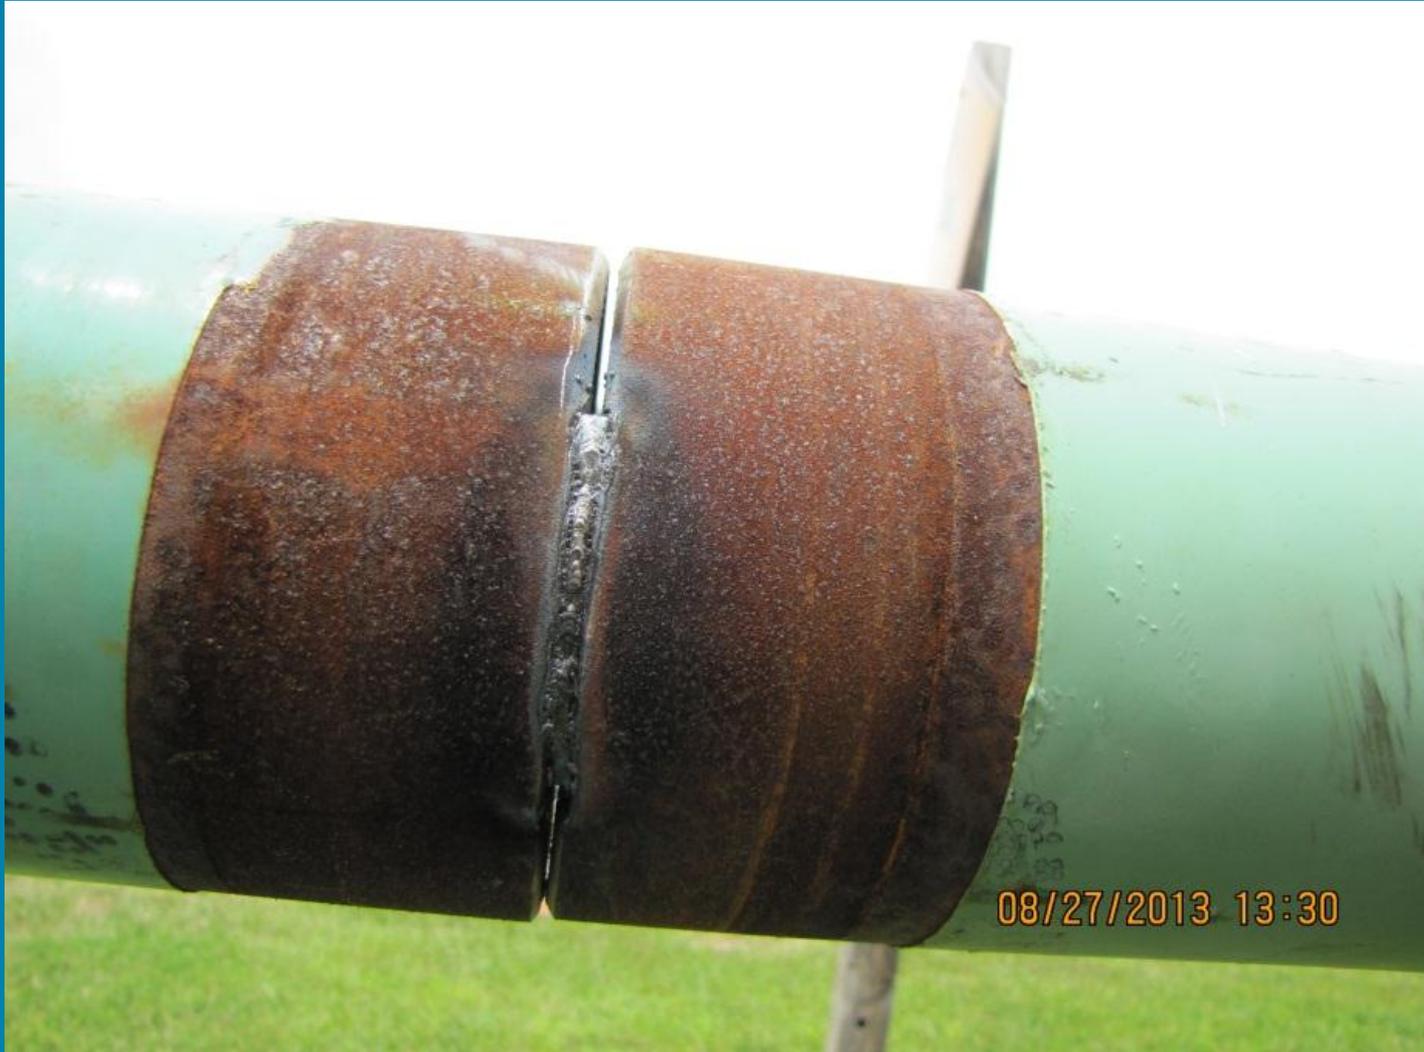
§ 192.235- Failure of the Company to preserve the alignment while the root bead is being deposited.

Understanding the manufacturer's procedures when they are referenced in the Operator's O&M.

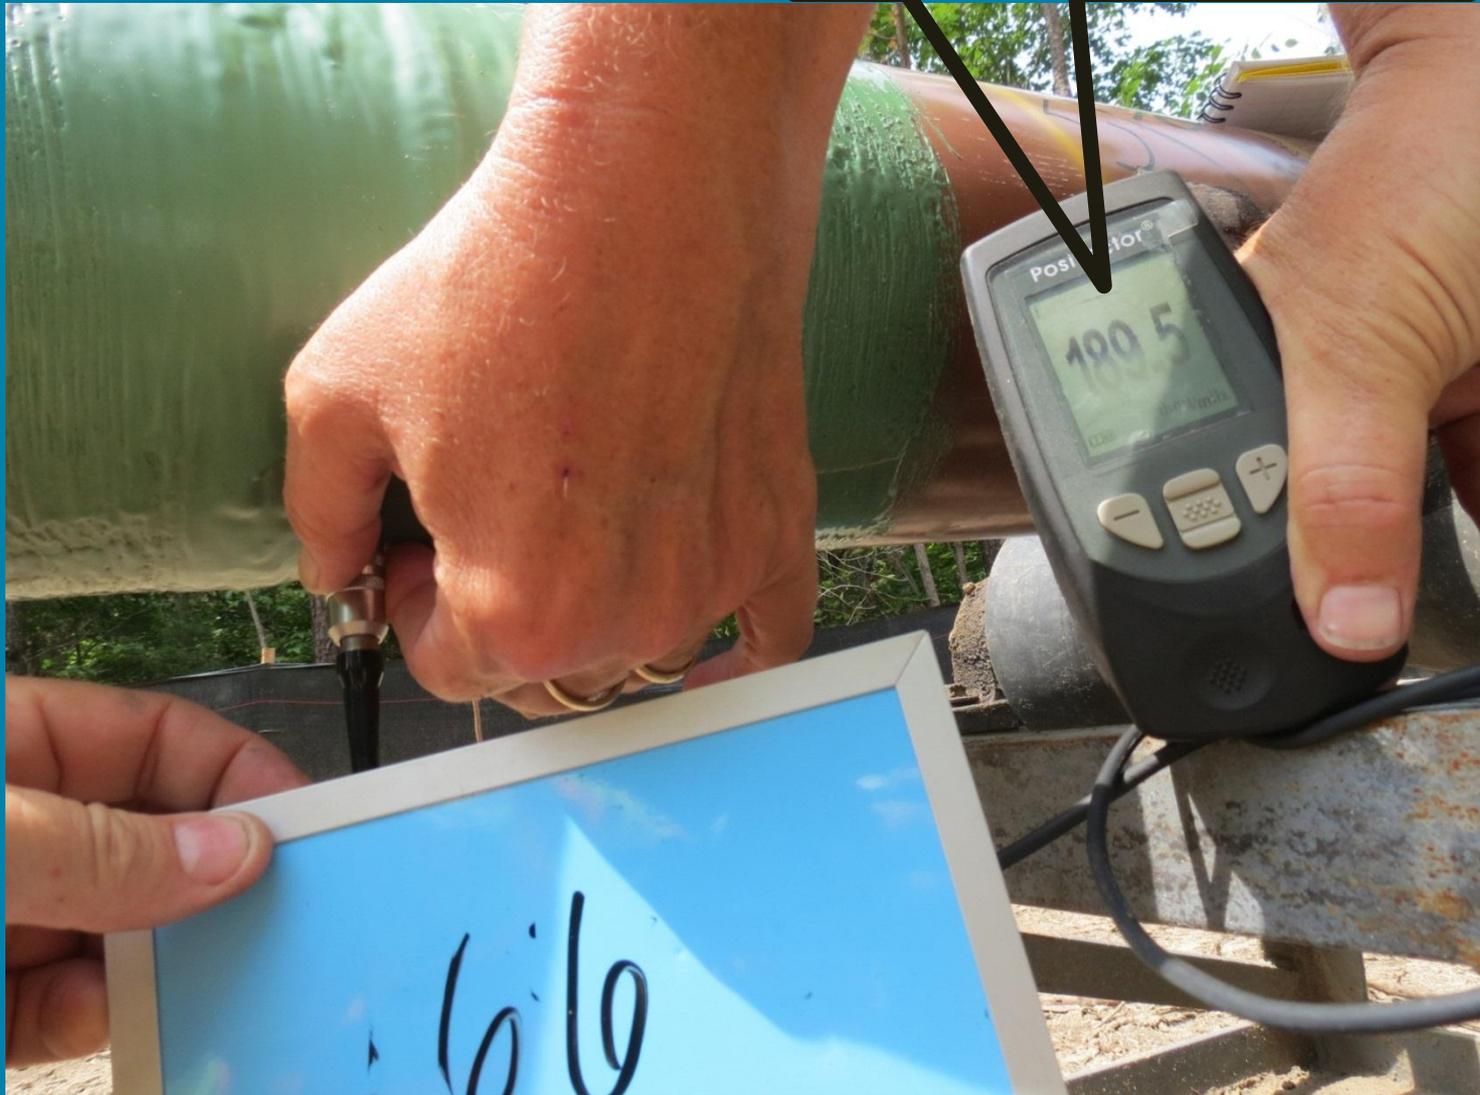
Understanding the manufacturer's procedures when they are referenced in the Operator's O&M. Get clarification when there is more than one interpretation.

Example: 2 coats would be 100 mils total thickness, 30 mils greater than recommended.

The Company inspector interpreted this as 50 mils per coat.

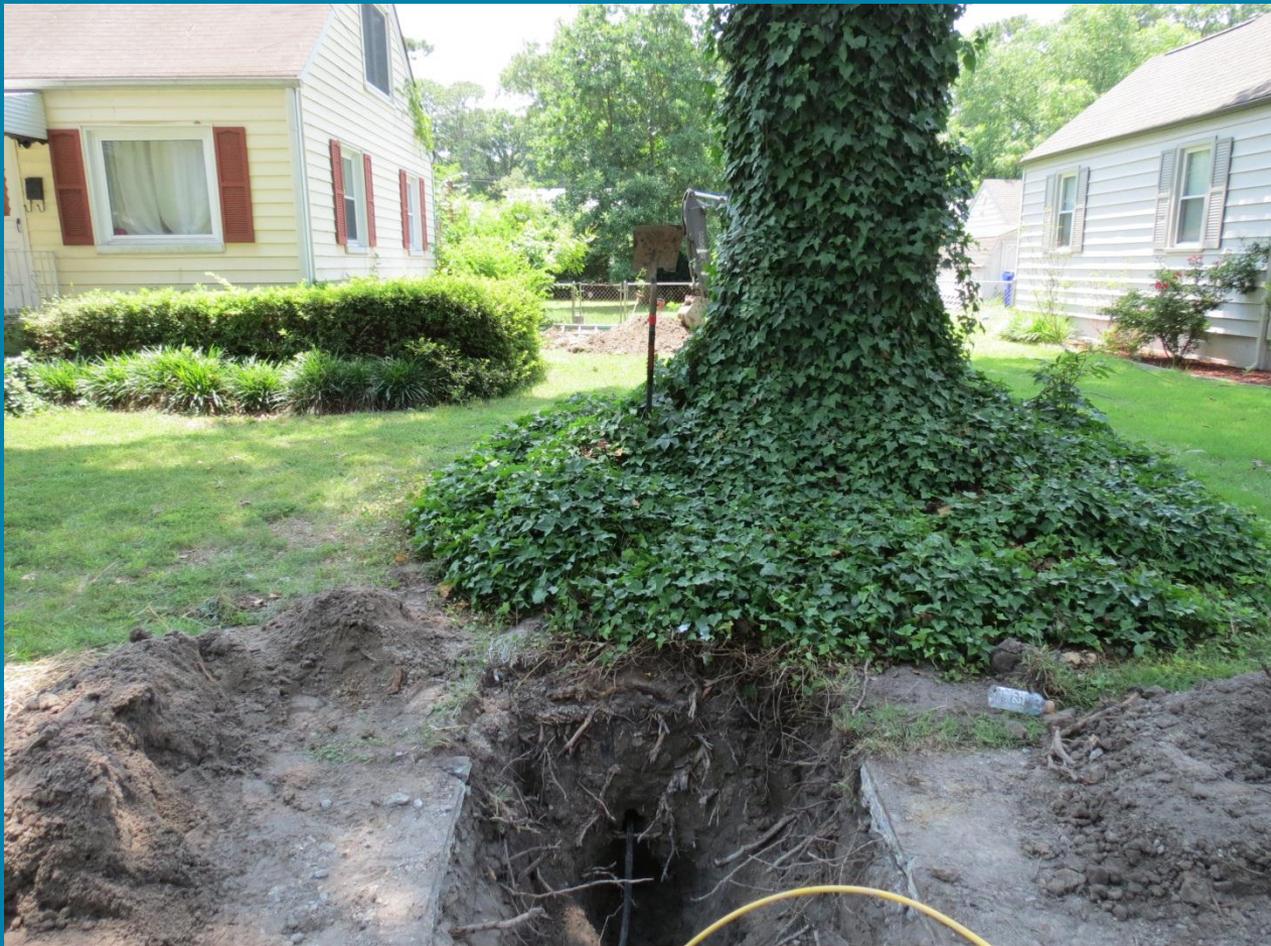
The inspector was not aware of the Operator's requirement for the installation of service lines under the root system of trees.
